Access Compliance Report

Public Rights-of-Way

(Curb Ramps)

Intersection ID: 11423	Main Street: S SUMMIT_AV	Cross Street: W 4TH_ST_EXT	Location: N
ADA ID: 575E7A49F57D	Ramp Type: Directional1	Initial Pass/Fail: Fail	Overall Compliance: No
		Severity Score: 12.5

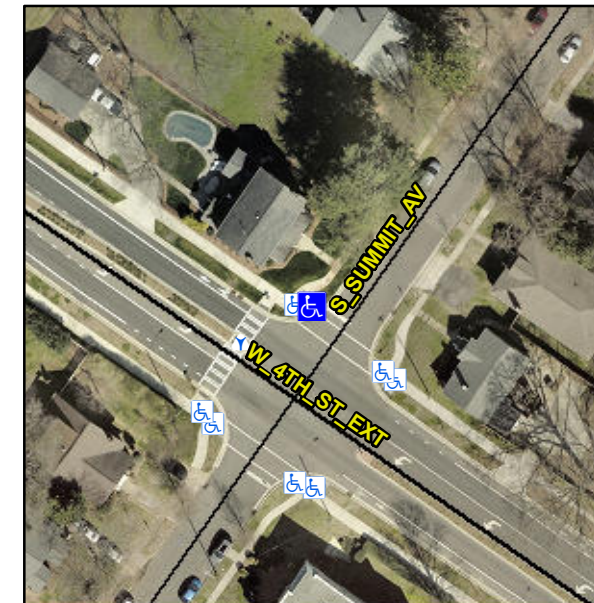
Compliance	Description	Data	Compliance	Description	Data
N/A	Ramp Length (in)	36.0	N/A	Grade Break?	N/A
Yes	Ramp Width (in)	70.0	N/A	Grade Break Slope (%)	0.0
No	Ramp Slope (%)	9.0	N/A	Grade Break XSlope (%)	0.0
Yes	Ramp XSlope (%)	1.9			
N/A	Flare Type LT	N/A	N/A	Flare Type RT	N/A
N/A	Flare Slope LT (%)	N/A	N/A	Flare Slope RT (%)	0.0
N/A	Flare Traversable LT?	N/A	N/A	Flare Traversable RT?	N/A
N/A	Landing Length (in)	0.0	N/A	DWS Provided?	N/A
N/A	Landing Width (in)	0.0	N/A	DWS Contrast?	N/A
N/A	Landing Slope (%)	0.0	N/A	DWS Length (in)	N/A
N/A	Landing X Slope (%)	0.0	N/A	DWS Full Width?	N/A
N/A	Landing Curb? (Y/N)	N/A	N/A	DWS Offset LT (in)	N/A
N/A	Shared Landing?	N/A	N/A	DWS Offset RT (in)	N/A
N/A	Gutter Ponding?	0.0	N/A	Gutter Slope (%)	N/A
N/A	Gutter Lip Ht (in)	0.0	N/A	Gutter X Slope (%)	N/A
N/A	Painted X Walk1?	No		Road Slope (%)	5.6
	X Walk 1 Direction	To SE		Road X Slope (%)	2.6
	X Walk 1 Width (in)	N/A		Clear Space?	N/A

X Walk 1 Slope (%)	5.6	N/A	Clear Space to XWalk (in)	N/A
	X Walk 1 X Slope (%)	2.6	N/A	Storm Grate/Utility Hazard?	N/A
N/A	Ramp inside XWalk1?	N/A		Storm Grate/Utility Type	
N/A	Any Obstructions?	N/A			N/A
	Obstruction Type		Yes	Surface Condition? (G/P)	Good
			N/A	Curb Slope (%)	2.4

Remove & Replace Entire Ramp.
