# Access Compliance Report

## Public Rights-of-Way

### (Curb Ramps)

Intersection ID: 12996	Main Street: HICKORY GROVE RD	Cross Street: LAWRENCE ORR RD	Location: SE
ADA ID: 57737E2C42B1	Ramp Type: PerpDiag	Initial Pass/Fail: Fail	Overall Compliance: No
Severity Score: 8.75			
Codes/Mitigation Info/Possible Solution		Field Measurements/Component Compliance

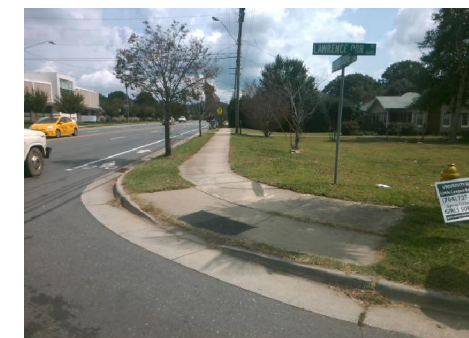
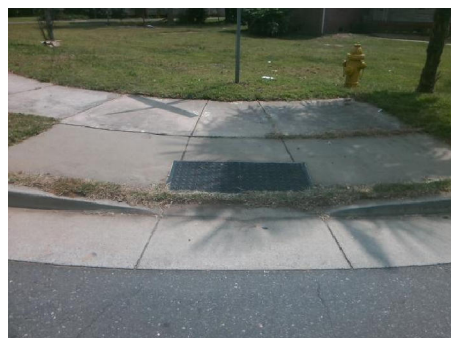
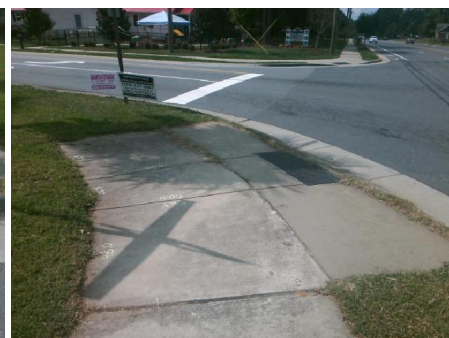
Street 1 Name HICKORY GROVE RD  
 Stop Condition-Street 2 None  
 Street 2 Name LAWRENCE ORR RD  
 Stop Condition-Street 1 StopSign
