Access Compliance Report

Public Rights-of-Way

(Curb Ramps)

Intersection ID: 13395	Main Street: LOVE_AV	Cross Street: N_SHARON_AMITY_RD	Location: SW
ADA ID: 57749116AB22	Ramp Type: Perp	Initial Pass/Fail: Fail	Overall Compliance: No
Codes/Mitigation Info/Possible Solution			Severity Score: 30
			Field Measurements/Component Compliance

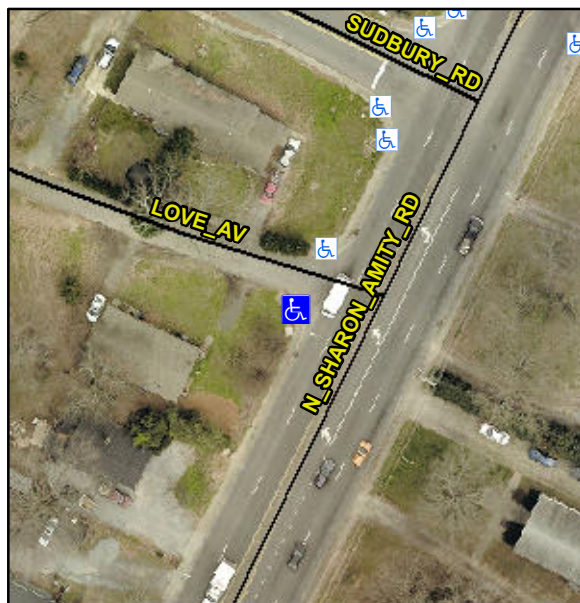
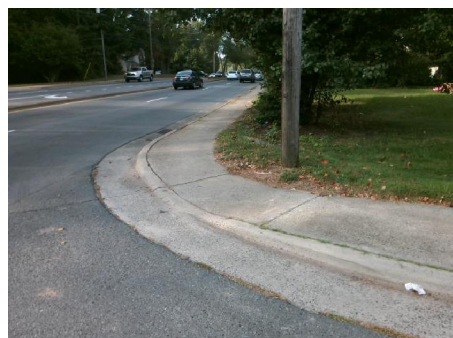
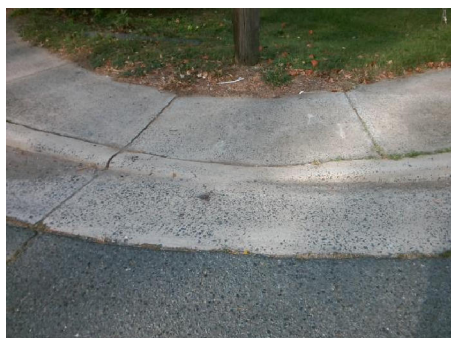
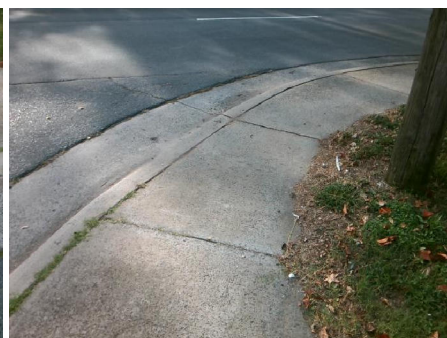
Not Found, R304.5.1, R304.2.2

Compliance	Description	Data	Compliance	Description	Data
N/A	Ramp Length (in)	60.0	No	Ramp Slope (%)	8.9
No	Ramp Width (in)	35.0	Yes	Ramp XSlope (%)	1.0
N/A	Flare Type LT	N/A	N/A	Flare Type RT	N/A
N/A	Flare Slope LT (%)	N/A	N/A	Flare Slope RT (%)	N/A
N/A	Flare Traversable LT?	N/A	N/A	Flare Traversable RT?	N/A
N/A	Landing Length (in)	N/A	N/A	DWS Provided?	N/A
N/A	Landing Width (in)	N/A	N/A	DWS Contrast?	N/A
N/A	Landing Slope (%)	N/A	N/A	DWS Length (in)	N/A
N/A	Landing X Slope (%)	N/A	N/A	DWS Full Width?	N/A
N/A	Landing Curb? (Y/N)	N/A	N/A	DWS Offset (in)	N/A
N/A	Shared Landing?	N/A			
N/A	Gutter Ponding?	N/A	N/A	Gutter Slope (%)	N/A
N/A	Gutter Lip Ht (in)	1.0	N/A	Gutter X Slope (%)	N/A
N/A	Painted X Walk1?	No	N/A	Painted X Walk2?	N/A
	X Walk 1 Direction	To NE		X Walk 2 Direction	N/A
N/A	X Walk 1 Width (in)	N/A	N/A	X Walk 2 Width (in)	N/A
	X Walk 1 Slope (%)	2.6		X Walk 2 Slope (%)	N/A
	X Walk 1 X Slope (%)	1.8		X Walk 2 X Slope (%)	N/A

N/A	Ramp inside XWalk1?	N/A	N/A	Ramp inside XWalk2?	N/A
	Road Slope (%)	N/A	N/A	Clear Space?	N/A
	Road X Slope (%)	N/A	N/A	Clear Space to XWalk (in)	N/A
N/A	Any Obstructions?	N/A	N/A	Storm Grate/Utility Hazard?	N/A
	Obstruction Type			Storm Grate/Utility Type	
		N/A			N/A
			Yes	Surface Condition? (G/P)	Good

Remove & Replace Entire Ramp.
