Access Compliance Report

Public Rights-of-Way

(Curb Ramps)

Intersection ID: 10037245	Main Street: SARDIS_CROSSING_DR	Cross Street: N/A	Location: SW
ADA ID: 577B3ACC3A8B	Ramp Type: Perp	Initial Pass/Fail: Fail	Overall Compliance: No
		Severity Score: 22.5

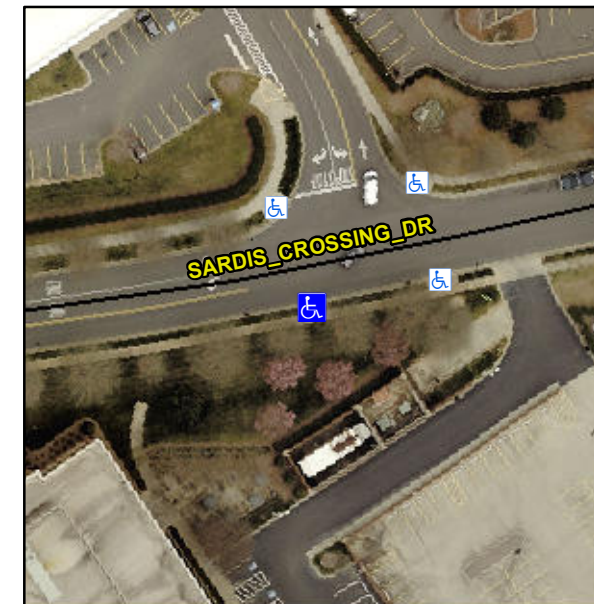
Not Found, R304.5.1, R304.2.2

Compliance	Description	Data	Compliance	Description	Data
N/A	Ramp Length (in)	47.0	No	Ramp Slope (%)	9.4
No	Ramp Width (in)	47.0	Yes	Ramp XSlope (%)	2.9
N/A	Flare Type LT	N/A	N/A	Flare Type RT	N/A
N/A	Flare Slope LT (%)	N/A	N/A	Flare Slope RT (%)	N/A
N/A	Flare Traversable LT?	N/A	N/A	Flare Traversable RT?	N/A
N/A	Landing Length (in)	N/A	N/A	DWS Provided?	N/A
N/A	Landing Width (in)	N/A	N/A	DWS Contrast?	N/A
N/A	Landing Slope (%)	N/A	N/A	DWS Length (in)	N/A
N/A	Landing X Slope (%)	N/A	N/A	DWS Full Width?	N/A
N/A	Landing Curb? (Y/N)	N/A	N/A	DWS Offset (in)	N/A
N/A	Shared Landing?	N/A			
N/A	Gutter Ponding?	N/A	N/A	Gutter Slope (%)	N/A
N/A	Gutter Lip Ht (in)	N/A	N/A	Gutter X Slope (%)	N/A
N/A	Painted X Walk1?	No	N/A	Painted X Walk2?	N/A
	X Walk 1 Direction	To N		X Walk 2 Direction	N/A
N/A	X Walk 1 Width (in)	N/A	N/A	X Walk 2 Width (in)	N/A
	X Walk 1 Slope (%)	2.1		X Walk 2 Slope (%)	N/A
	X Walk 1 X Slope (%)	3.4		X Walk 2 X Slope (%)	N/A

N/A	Ramp inside XWalk1?	N/A	N/A	Ramp inside XWalk2?	N/A
	Road Slope (%)	N/A	N/A	Clear Space?	N/A
	Road X Slope (%)	N/A	N/A	Clear Space to XWalk (in)	N/A
N/A	Any Obstructions?	N/A	N/A	Storm Grate/Utility Hazard?	N/A
	Obstruction Type			Storm Grate/Utility Type	
		N/A			N/A
			Yes	Surface Condition? (G/P)	Good

Remove & Replace Entire Ramp.
