# Access Compliance Report

## Public Rights-of-Way

### (Curb Ramps)

Intersection ID: 47971	Main Street: SOUTH_CREEK_RD	Cross Street: KYRENE_RD	Location: S
ADA ID: 577E4C103BDE	Ramp Type: BlendTrans1	Initial Pass/Fail: Fail	Overall Compliance: No
		Severity Score: 8.75

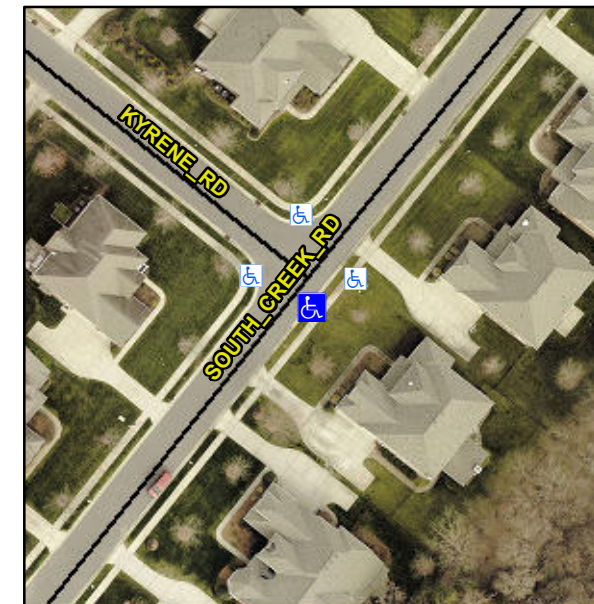
Compliance	Description	Data	Compliance	Description	Data
N/A	Ramp Length (in)	47.0	Yes	BlendTrans Slope (%)	1.8
No	Ramp Width (in)	47.0	Yes	BlendTrans XSlope (%)	0.9
N/A	Flare Type LT	N/A	N/A	Flare Type RT	N/A
N/A	Flare Slope LT (%)	N/A	N/A	Flare Slope RT (%)	N/A
N/A	Flare Traversable LT?	N/A	N/A	Flare Traversable RT?	N/A
N/A	Landing Length (in)	N/A	N/A	DWS Provided?	N/A
N/A	Landing Width (in)	N/A	N/A	DWS Contrast?	N/A
N/A	Landing Slope (%)	N/A	N/A	DWS Length (in)	N/A
N/A	Landing X Slope (%)	N/A	N/A	DWS Full Width?	N/A
N/A	Landing Curb? (Y/N)	N/A	N/A	DWS Offset (in)	N/A
N/A	Shared Landing?	N/A			
N/A	Gutter Ponding?	N/A	N/A	Gutter Slope (%)	N/A
N/A	Gutter Lip Ht (in)	N/A	N/A	Gutter X Slope (%)	N/A
N/A	Painted X Walk1?	No	N/A	Painted X Walk2?	N/A
	X Walk 1 Direction	To NW		X Walk 2 Direction	N/A
	X Walk 1 Width (in)	N/A		X Walk 2 Width (in)	N/A
	X Walk 1 Slope (%)	0.9		X Walk 2 Slope (%)	N/A
	X Walk 1 X Slope (%)	0.4		X Walk 2 X Slope (%)	N/A

N/A	Ramp inside XWalk1?	N/A	N/A	Ramp inside XWalk2?	N/A
	Road Slope (%)	0.4		Clear Space?	N/A
	Road X Slope (%)	0.9	N/A	Clear Space to XWalk (in)	N/A
N/A	Any Obstructions?	N/A	N/A	Storm Grate/Utility Hazard?	N/A
	Obstruction Type			Storm Grate/Utility Type	
		N/A			N/A
			Yes	Surface Condition? (G/P)	Good
			N/A	Curb Slope (%)	3.3

**Remove & Replace Curb Ramp With Two New Directional Ramps or Equivalent.**

**R304.5.1**
