Access Compliance Report Public Rights-of-Way (Curb Ramps)

Intersection ID: 30263 Main Street: BLYTHEDALE_DR Cross Street: FORTESCUE_DR Location: E

ADA ID: 5783CD9C8616 Ramp Type: PerpDiag Initial Pass/Fail: Fail Overall Compliance: No Severity Score: 12.5

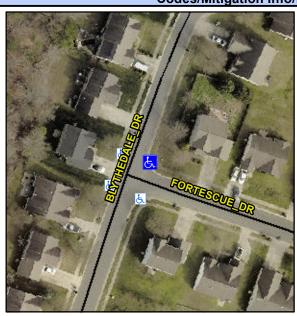
PROW/ADA:
Not Found, R304.5.3

r leid Measurements/Component Compilance					
Compliance Description		Data	Compliance Description		Data
N/A	Ramp Length (in)	48.0	Yes	Ramp Slope (%)	5.1
Yes	Ramp Width (in)	48.0	No	Ramp XSlope (%)	5.2
N/A	Flare Type LT	N/A	N/A	Flare Type RT	N/A
N/A	Flare Slope LT (%)	N/A	N/A	Flare Slope RT (%)	N/A
N/A	Flare Traversable LT?	N/A	N/A	Flare Traversable RT?	N/A
N/A	Landing Length (in)	N/A	N/A	DWS Provided?	N/A
N/A	Landing Width (in)	N/A	N/A	DWS Contrast?	N/A
N/A	Landing Slope (%)	N/A	N/A	DWS Length (in)	N/A
N/A	Landing X Slope (%)	N/A	N/A	DWS Full Width?	N/A
N/A	Landing Curb? (Y/N)	N/A	N/A	DWS Offset (in)	N/A
N/A	Shared Landing?	N/A			
N/A	Gutter Ponding?	N/A	N/A	Gutter Slope (%)	N/A
N/A	Gutter Lip Ht (in)	N/A	N/A	Gutter X Slope (%)	N/A
N/A	Painted X Walk1?	No	N/A	Painted X Walk2?	No
	X Walk 1 Direction	To N		X Walk 2 Direction	To S
N/A	X Walk 1 Width (in)	N/A	N/A	X Walk 2 Width (in)	N/A
	X Walk 1 Slope (%)	6.5		X Walk 2 Slope (%)	5.2

X Walk 1 X Slope (%)	4.0		X Walk 2 X Slope (%)	0.4
N/A	Ramp inside XWalk1?	N/A	N/A	Ramp inside XWalk2?	N/A
	Road Slope (%)	0.7	N/A	Clear Space?	N/A
	Road X Slope (%)	4.7	N/A	Clear Space to XWalk (in)	N/A
N/A	Any Obstructions?	N/A	N/A	Storm Grate/Utility Hazard?	N/A

Possible Solutions:
Remove & Replace Curb Ramp With Two New Directional Ramps or Equivalent.
