Access Compliance Report

Public Rights-of-Way

(Curb Ramps)

Intersection ID: 10257	Main Street: E_36TH_ST	Cross Street: N_MCDOWELL_ST	Location: S
ADA ID: 578704A72FC9	Ramp Type: Perp	Initial Pass/Fail: Fail	Overall Compliance: No
Severity Score: 10			
Codes/Mitigation Info/Possible Solution		Field Measurements/Component Compliance

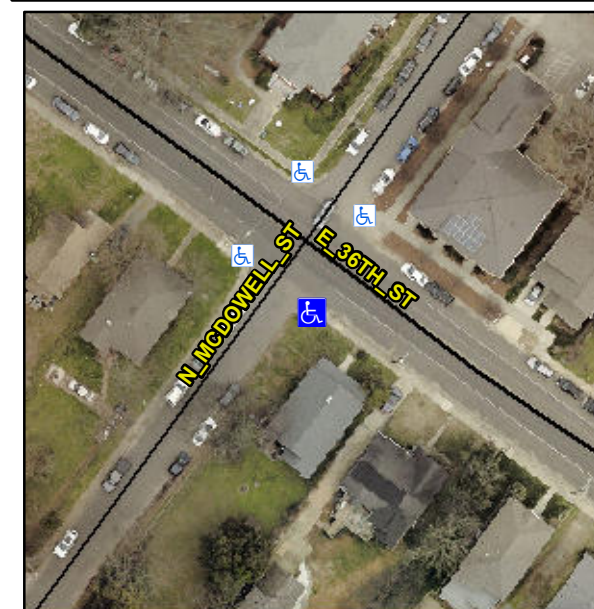
Not Found, R304.5.1, R304.5.3

Compliance	Description	Data	Compliance	Description	Data
N/A	Ramp Length (in)	60.0	Yes	Ramp Slope (%)	5.8
No	Ramp Width (in)	47.0	No	Ramp XSlope (%)	2.1
N/A	Flare Type LT	N/A	N/A	Flare Type RT	N/A
N/A	Flare Slope LT (%)	N/A	N/A	Flare Slope RT (%)	N/A
N/A	Flare Traversable LT?	N/A	N/A	Flare Traversable RT?	N/A
N/A	Landing Length (in)	N/A	N/A	DWS Provided?	N/A
N/A	Landing Width (in)	N/A	N/A	DWS Contrast?	N/A
N/A	Landing Slope (%)	N/A	N/A	DWS Length (in)	N/A
N/A	Landing X Slope (%)	N/A	N/A	DWS Full Width?	N/A
N/A	Landing Curb? (Y/N)	N/A	N/A	DWS Offset (in)	N/A
N/A	Shared Landing?	N/A			
N/A	Gutter Ponding?	N/A	N/A	Gutter Slope (%)	N/A
N/A	Gutter Lip Ht (in)	N/A	N/A	Gutter X Slope (%)	N/A
N/A	Painted X Walk1?	No	N/A	Painted X Walk2?	N/A
	X Walk 1 Direction	To NW		X Walk 2 Direction	N/A
N/A	X Walk 1 Width (in)	N/A	N/A	X Walk 2 Width (in)	N/A
	X Walk 1 Slope (%)	0.2		X Walk 2 Slope (%)	N/A
	X Walk 1 X Slope (%)	0.0		X Walk 2 X Slope (%)	N/A

N/A	Ramp inside XWalk1?	N/A	N/A	Ramp inside XWalk2?	N/A
	Road Slope (%)	N/A	N/A	Clear Space?	N/A
	Road X Slope (%)	N/A	N/A	Clear Space to XWalk (in)	N/A
N/A	Any Obstructions?	N/A	N/A	Storm Grate/Utility Hazard?	N/A
	Obstruction Type			Storm Grate/Utility Type	
		N/A			N/A
		Yes		Surface Condition? (G/P)	Good

Possible Solutions:

Remove & Replace Entire Ramp.
