Access Compliance Report

Public Rights-of-Way

(Curb Ramps)

Intersection ID: N/A	Main Street: WINDYGAP_RD	Cross Street: SELKIRKSHIRE_RD	Location:	NE
ADA ID: 57870A9B6751	Ramp Type: Perp	Initial Pass/Fail: Fail	Overall Compliance: No	Severity Score: 12.5

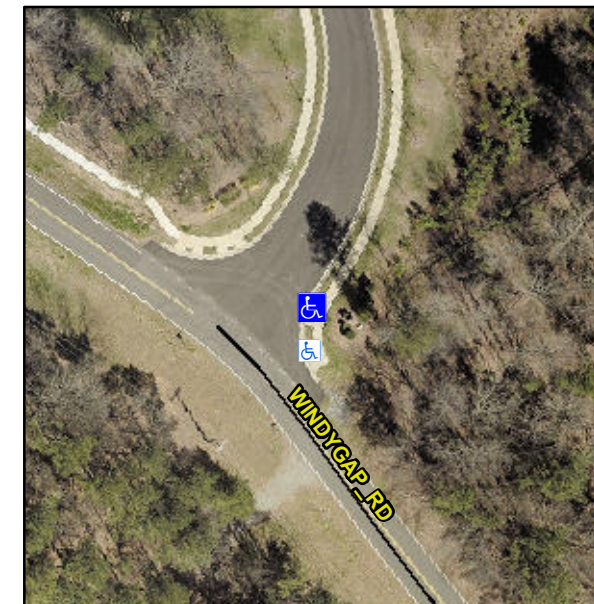
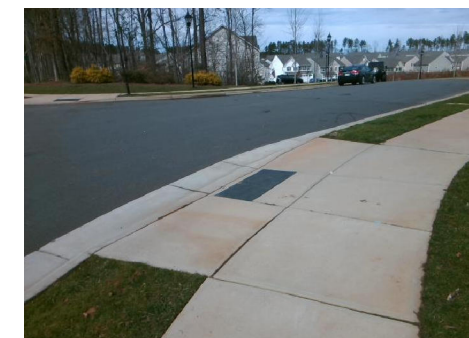
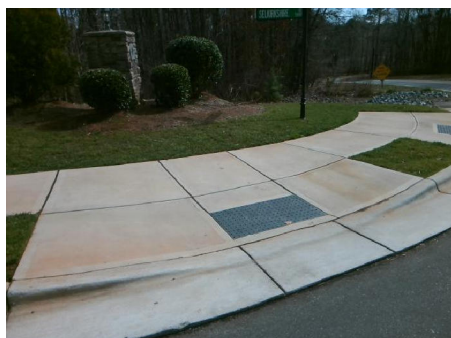
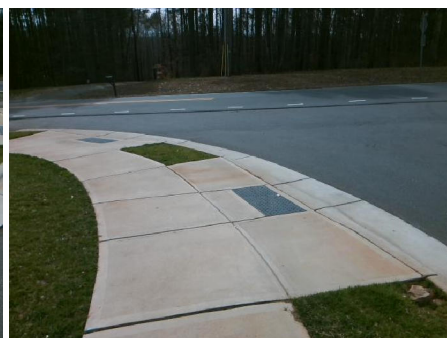
Not Found, R304.5.3

Compliance	Description	Data	Compliance	Description	Data
N/A	Ramp Length (in)	108.0	Yes	Ramp Slope (%)	5.4
Yes	Ramp Width (in)	48.0	No	Ramp XSlope (%)	5.1
N/A	Flare Type LT	N/A	N/A	Flare Type RT	N/A
N/A	Flare Slope LT (%)	N/A	N/A	Flare Slope RT (%)	N/A
N/A	Flare Traversable LT?	N/A	N/A	Flare Traversable RT?	N/A
N/A	Landing Length (in)	N/A	N/A	DWS Provided?	N/A
N/A	Landing Width (in)	N/A	N/A	DWS Contrast?	N/A
N/A	Landing Slope (%)	N/A	N/A	DWS Length (in)	N/A
N/A	Landing X Slope (%)	N/A	N/A	DWS Full Width?	N/A
N/A	Landing Curb? (Y/N)	N/A	N/A	DWS Offset (in)	N/A
N/A	Shared Landing?	N/A			
N/A	Gutter Ponding?	N/A	N/A	Gutter Slope (%)	N/A
N/A	Gutter Lip Ht (in)	1.3	N/A	Gutter X Slope (%)	N/A
N/A	Painted X Walk1?	No	N/A	Painted X Walk2?	N/A
	X Walk 1 Direction	To NW		X Walk 2 Direction	N/A
N/A	X Walk 1 Width (in)	N/A	N/A	X Walk 2 Width (in)	N/A
	X Walk 1 Slope (%)	3.2		X Walk 2 Slope (%)	N/A
	X Walk 1 X Slope (%)	4.0		X Walk 2 X Slope (%)	N/A

N/A	Ramp inside XWalk1?	N/A	N/A	Ramp inside XWalk2?	N/A
	Road Slope (%)	N/A	N/A	Clear Space?	N/A
	Road X Slope (%)	N/A	N/A	Clear Space to XWalk (in)	N/A
N/A	Any Obstructions?	N/A	N/A	Storm Grate/Utility Hazard?	N/A
	Obstruction Type			Storm Grate/Utility Type	
		N/A			N/A
			Yes	Surface Condition? (G/P)	Good

Remove & Replace Entire Ramp.
