Access Compliance Report

Public Rights-of-Way

(Curb Ramps)

Intersection ID: 45177	Main Street: ELDON_DR	Cross Street: GARLAND_CT	Location: NE
ADA ID: 578F2EF68652	Ramp Type: Perp	Initial Pass/Fail: Fail	Overall Compliance: No
Severity Score: 35			
Codes/Mitigation Info/Possible Solution		Field Measurements/Component Compliance

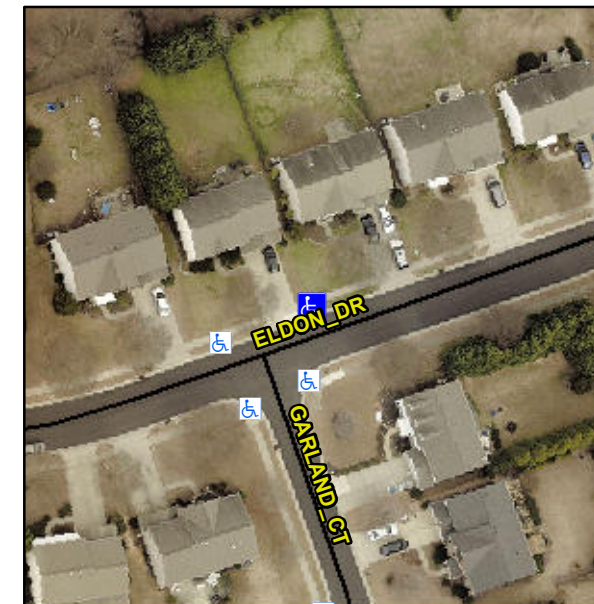
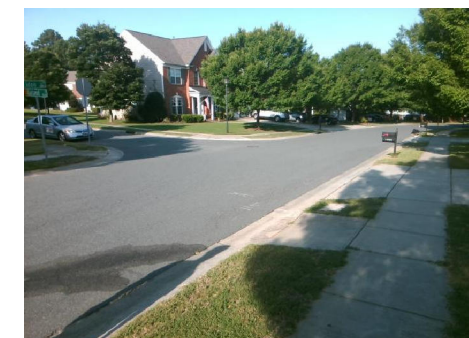
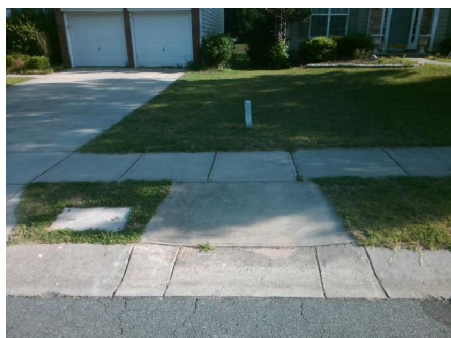
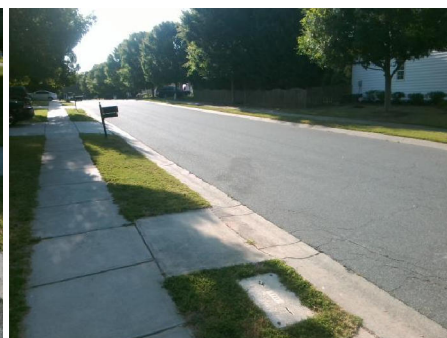
Not Found, R304.5.1, R304.2.2

Compliance	Description	Data	Compliance	Description	Data
N/A	Ramp Length (in)	47.0	No	Ramp Slope (%)	13.1
No	Ramp Width (in)	46.5	Yes	Ramp XSlope (%)	2.1
N/A	Flare Type LT	N/A	N/A	Flare Type RT	N/A
N/A	Flare Slope LT (%)	N/A	N/A	Flare Slope RT (%)	N/A
N/A	Flare Traversable LT?	N/A	N/A	Flare Traversable RT?	N/A
N/A	Landing Length (in)	N/A	N/A	DWS Provided?	N/A
N/A	Landing Width (in)	N/A	N/A	DWS Contrast?	N/A
N/A	Landing Slope (%)	N/A	N/A	DWS Length (in)	N/A
N/A	Landing X Slope (%)	N/A	N/A	DWS Full Width?	N/A
N/A	Landing Curb? (Y/N)	N/A	N/A	DWS Offset (in)	N/A
N/A	Shared Landing?	N/A			
N/A	Gutter Ponding?	N/A	N/A	Gutter Slope (%)	N/A
N/A	Gutter Lip Ht (in)	N/A	N/A	Gutter X Slope (%)	N/A
N/A	Painted X Walk1?	No	N/A	Painted X Walk2?	N/A
	X Walk 1 Direction	To SW		X Walk 2 Direction	N/A
N/A	X Walk 1 Width (in)	N/A	N/A	X Walk 2 Width (in)	N/A
	X Walk 1 Slope (%)	0.7		X Walk 2 Slope (%)	N/A
	X Walk 1 X Slope (%)	3.7		X Walk 2 X Slope (%)	N/A

N/A	Ramp inside XWalk1?	N/A	N/A	Ramp inside XWalk2?	N/A
	Road Slope (%)	N/A	N/A	Clear Space?	N/A
	Road X Slope (%)	N/A	N/A	Clear Space to XWalk (in)	N/A
N/A	Any Obstructions?	N/A	N/A	Storm Grate/Utility Hazard?	N/A
	Obstruction Type			Storm Grate/Utility Type	
		N/A			N/A
			Yes	Surface Condition? (G/P)	Good

Possible Solutions:

Remove & Replace Entire Ramp.
