# Access Compliance Report

## Public Rights-of-Way (Curb Ramps)

Intersection ID: 5877	Main Street: COULWOOD_DR	Cross Street: WYNDALE_TR	Location:	W
ADA ID: 579E6307DC24	Ramp Type: Directional1	Initial Pass/Fail: Pass	Overall Compliance: No	Severity Score: 2.5

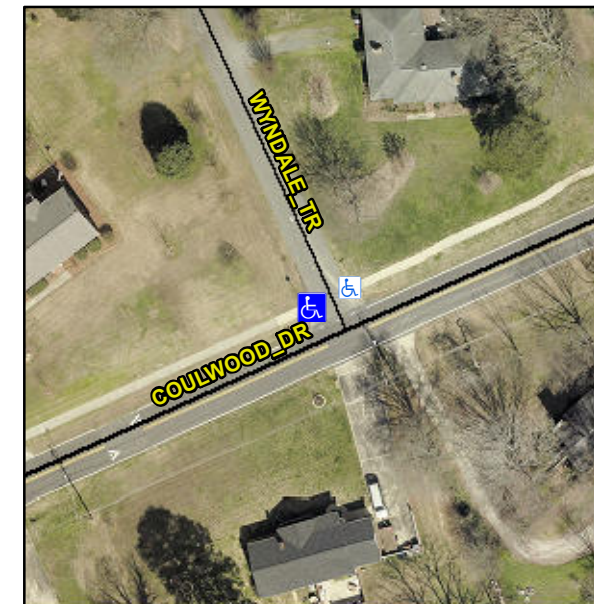
**NO CURB**

Compliance	Description	Data	Compliance	Description	Data
N/A	Ramp Length (in)	46.0	Yes	Grade Break?	Yes
Yes	Ramp Width (in)	60.0	Yes	Grade Break Slope (%)	2.8
Yes	Ramp Slope (%)	7.0	Yes	Grade Break XSlope (%)	1.0
Yes	Ramp XSlope (%)	1.1			
N/A	Flare Type LT	N/A	N/A	Flare Type RT	N/A
N/A	Flare Slope LT (%)	N/A	N/A	Flare Slope RT (%)	N/A
N/A	Flare Traversable LT?	N/A	N/A	Flare Traversable RT?	N/A
Yes	Landing Length (in)	52.0	Yes	DWS Provided?	Yes
Yes	Landing Width (in)	60.0	Yes	DWS Contrast?	Yes
No	Landing Slope (%)	5.1	Yes	DWS Length (in)	24.0
Yes	Landing X Slope (%)	0.1	No	DWS Full Width?	No
N/A	Landing Curb? (Y/N)	N/A	No	DWS Offset LT (in)	10.5
N/A	Shared Landing?	No	Yes	DWS Offset RT (in)	22.5
Yes	Gutter Ponding?	No	Yes	Gutter Slope (%)	1.2
Yes	Gutter Lip Ht (in)	0.0	No	Gutter X Slope (%)	4.4
N/A	Painted X Walk1?	No		Road Slope (%)	1.9
	X Walk 1 Direction	To NE		Road X Slope (%)	2.3
	X Walk 1 Width (in)	N/A		Clear Space?	Yes

X Walk 1 Slope (%)	1.9	N/A	Clear Space to XWalk (in)	N/A
	X Walk 1 X Slope (%)	2.3	Yes	Storm Grate/Utility Hazard?	No
N/A	Ramp inside XWalk1?	N/A		Storm Grate/Utility Type	
Yes	Any Obstructions?	No			N/A
	Obstruction Type		Yes	Surface Condition? (G/P)	Good
			N/A	Curb Slope (%)	N/A

**Remove & Replace Entire Ramp.  
Remove & Replace Gutter.**
