Access Compliance Report Public Rights-of-Way (Curb Ramps)

Intersection ID: 26138 Main Street: HARROWFIELD_RD Cross Street: JOHNSTON_RD Location: SW

ADA ID: 57A3E7E4EA00 Ramp Type: Perp Initial Pass/Fail: Fail Overall Compliance: No Severity Score: 33.75

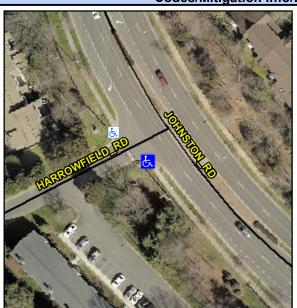
Not Found, R304.5.1, R304.2.2

Comp	liance Description	Data	Comp	liance	Description	Data
N/A	Ramp Length (in)	60.0	No	Ramp	Slope (%)	12.4
No	Ramp Width (in)	43.0	Yes	Yes Ramp XSlope (%)		0.2
N/A	Flare Type LT	N/A	N/A	Flare	Type RT	N/A
N/A	Flare Slope LT (%)	N/A	N/A	Flare	Slope RT (%)	N/A
N/A	Flare Traversable LT?	N/A	N/A	Flare	Traversable RT?	N/A
N/A	Landing Length (in)	N/A	N/A	DWS	Provided?	N/A
N/A	Landing Width (in)	N/A	N/A	DWS	Contrast?	N/A
N/A	Landing Slope (%)	N/A	N/A	DWS	Length (in)	N/A
N/A	Landing X Slope (%)	N/A	N/A	DWS	Full Width?	N/A
N/A	Landing Curb? (Y/N)	N/A	N/A	DWS	Offset (in)	N/A
N/A	Shared Landing?	N/A				
N/A	Gutter Ponding?	N/A	N/A	Gutte	r Slope (%)	N/A
N/A	Gutter Lip Ht (in)	N/A	N/A	Gutte	r X Slope (%)	N/A
N/A	Painted X Walk1?	No	N/A	Paint	ed X Walk2?	N/A
	X Walk 1 Direction	To NW		X Wa	lk 2 Direction	N/A
N/A	X Walk 1 Width (in)	N/A	N/A	X Wa	lk 2 Width (in)	N/A
	X Walk 1 Slope (%)	1.9		X Wa	lk 2 Slope (%)	N/A
	X Walk 1 X Slope (%)	0.8		X Wa	lk 2 X Slope (%)	N/A

Remove & Replace Entire Ramp.
