# Access Compliance Report

## Public Rights-of-Way

### (Curb Ramps)

Intersection ID: 29523	Main Street: SEDGEWOOD_CR	Cross Street: SEDGEWOOD_PLACE_CT	Location: E
ADA ID: 57A921D44E77	Ramp Type: PerpDiag	Initial Pass/Fail: Fail	Overall Compliance: No
		Severity Score: 12.5

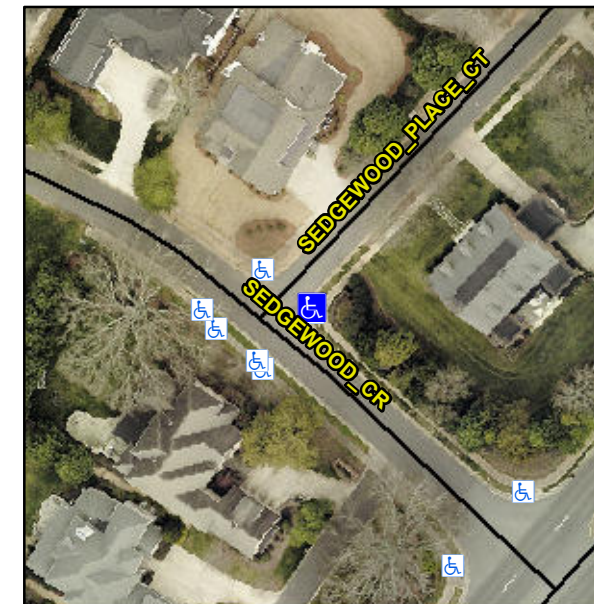
Compliance	Description	Data	Compliance	Description	Data
N/A	Ramp Length (in)	49.0	No	Ramp Slope (%)	9.3
Yes	Ramp Width (in)	48.0	Yes	Ramp XSlope (%)	1.3
N/A	Flare Type LT	N/A	N/A	Flare Type RT	N/A
N/A	Flare Slope LT (%)	N/A	N/A	Flare Slope RT (%)	N/A
N/A	Flare Traversable LT?	N/A	N/A	Flare Traversable RT?	N/A
N/A	Landing Length (in)	N/A	N/A	DWS Provided?	N/A
N/A	Landing Width (in)	N/A	N/A	DWS Contrast?	N/A
N/A	Landing Slope (%)	N/A	N/A	DWS Length (in)	N/A
N/A	Landing X Slope (%)	N/A	N/A	DWS Full Width?	N/A
N/A	Landing Curb? (Y/N)	N/A	N/A	DWS Offset (in)	N/A
N/A	Shared Landing?	N/A			
N/A	Gutter Ponding?	N/A	N/A	Gutter Slope (%)	N/A
N/A	Gutter Lip Ht (in)	N/A	N/A	Gutter X Slope (%)	N/A
N/A	Painted X Walk1?	No	N/A	Painted X Walk2?	No
	X Walk 1 Direction	To NW		X Walk 2 Direction	To SW
N/A	X Walk 1 Width (in)	N/A	N/A	X Walk 2 Width (in)	N/A
	X Walk 1 Slope (%)	0.4		X Walk 2 Slope (%)	2.3
	X Walk 1 X Slope (%)	1.8		X Walk 2 X Slope (%)	0.8

N/A	Ramp inside XWalk1?	N/A	N/A	Ramp inside XWalk2?	N/A
	Road Slope (%)	1.0	N/A	Clear Space?	N/A
	Road X Slope (%)	3.1	N/A	Clear Space to XWalk (in)	N/A
N/A	Any Obstructions?	N/A	N/A	Storm Grate/Utility Hazard?	N/A
	Obstruction Type			Storm Grate/Utility Type	
		N/A			N/A
		Yes		Surface Condition? (G/P)	Good

**Remove & Replace Curb Ramp With Two New Directional Ramps or Equivalent.**

**Not Found, R304.2.2**
