# Access Compliance Report

## Public Rights-of-Way

### (Curb Ramps)

Intersection ID: 20578	Main Street: EMERALD_MEADOW_LN	Cross Street: ENGLISH_SADDLE_LN	Location: S
ADA ID: 57A942E8612A	Ramp Type: PerpDiag	Initial Pass/Fail: Fail	Overall Compliance: No
Codes/Mitigation Info/Possible Solution		Field Measurements/Component Compliance	
Severity Score: 33.75

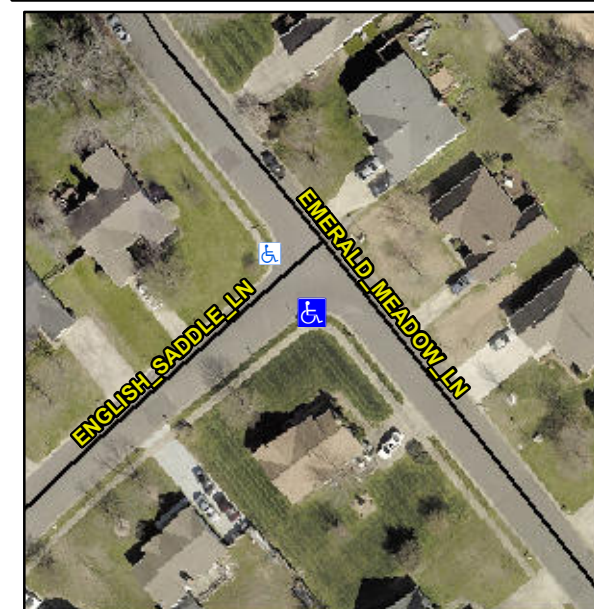
Compliance	Description	Data	Compliance	Description	Data
N/A	Ramp Length (in)	46.0	No	Ramp Slope (%)	8.9
No	Ramp Width (in)	43.0	No	Ramp XSlope (%)	6.3
N/A	Flare Type LT	N/A	N/A	Flare Type RT	N/A
N/A	Flare Slope LT (%)	N/A	N/A	Flare Slope RT (%)	N/A
N/A	Flare Traversable LT?	N/A	N/A	Flare Traversable RT?	N/A
N/A	Landing Length (in)	N/A	N/A	DWS Provided?	N/A
N/A	Landing Width (in)	N/A	N/A	DWS Contrast?	N/A
N/A	Landing Slope (%)	N/A	N/A	DWS Length (in)	N/A
N/A	Landing X Slope (%)	N/A	N/A	DWS Full Width?	N/A
N/A	Landing Curb? (Y/N)	N/A	N/A	DWS Offset (in)	N/A
N/A	Shared Landing?	N/A			
N/A	Gutter Ponding?	N/A	N/A	Gutter Slope (%)	N/A
N/A	Gutter Lip Ht (in)	N/A	N/A	Gutter X Slope (%)	N/A
N/A	Painted X Walk1?	No	N/A	Painted X Walk2?	No
	X Walk 1 Direction	To NE		X Walk 2 Direction	To NW
N/A	X Walk 1 Width (in)	N/A	N/A	X Walk 2 Width (in)	N/A
	X Walk 1 Slope (%)	5.7		X Walk 2 Slope (%)	2.8
	X Walk 1 X Slope (%)	2.6		X Walk 2 X Slope (%)	4.8

N/A	Ramp inside XWalk1?	N/A	N/A	Ramp inside XWalk2?	N/A
	Road Slope (%)	4.1	N/A	Clear Space?	N/A
	Road X Slope (%)	2.8	N/A	Clear Space to XWalk (in)	N/A
N/A	Any Obstructions?	N/A	N/A	Storm Grate/Utility Hazard?	N/A
	Obstruction Type			Storm Grate/Utility Type	
		N/A			N/A
			Yes	Surface Condition? (G/P)	Good

Possible Solutions:

**Remove & Replace Curb Ramp With Two New Directional Ramps or Equivalent.**

**R304.5.1, R304.2.2, R304.5.3**

Total Cost: \$ 3200.00
