# Access Compliance Report

## Public Rights-of-Way

### (Curb Ramps)

| Intersection ID: 43533 | Main Street: REDSPIRE_DR | Cross Street: PLANTERS_WATCH_DR | Location: NW |

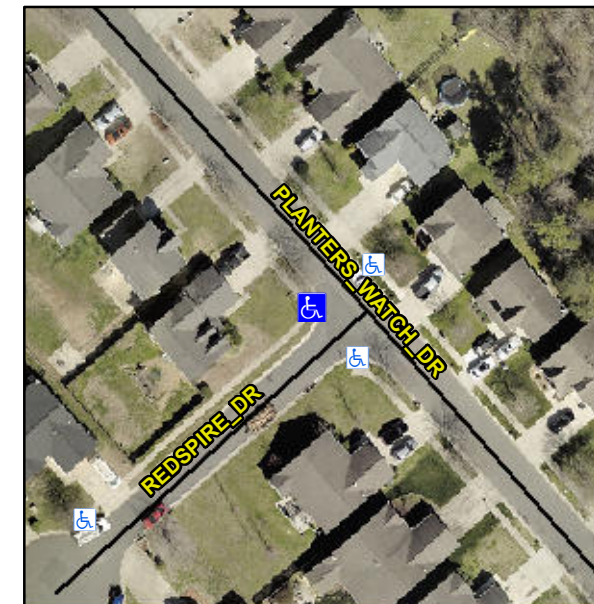
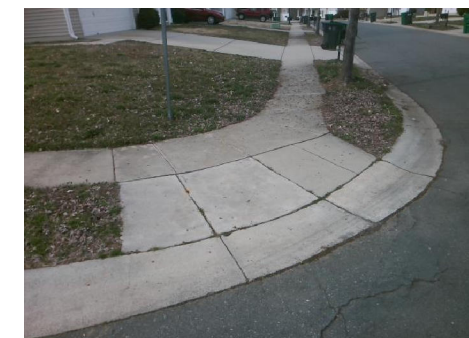
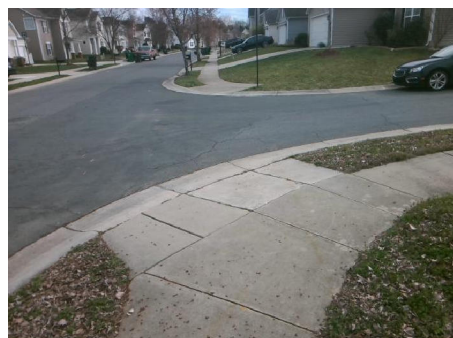
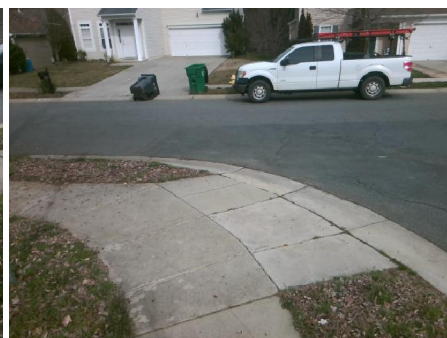
| ADA ID: 57C80A2A7ADA | Ramp Type: PerpDiag | Initial Pass/Fail: Fail | Overall Compliance: No |

| Compliance | Description | Data | Compliance | Description | Data |
|---|---|---|---|---|---|
| N/A | Ramp Length (in) | 46.0 | No | Ramp Slope (%) | 10.3 |
| No | Ramp Width (in) | 38.0 | No | Ramp XSlope (%) | 3.7 |

**Remove & Replace Curb Ramp With Two New Directional Ramps or Equivalent.**

**R304.5.1, R304.2.2, R304.5.3**
