# Access Compliance Report

## Public Rights-of-Way

### (Curb Ramps)

Intersection ID: 8816	Main Street: BROOKSTEAD_MEADOW_CT	Cross Street: NORKETT_DR	Location:	N
ADA ID: 57C9FD4802DD	Ramp Type: Perp	Initial Pass/Fail: Fail	Overall Compliance: No	Severity Score: 8.75
Codes/Mitigation Info/Possible Solution		Field Measurements/Component Compliance

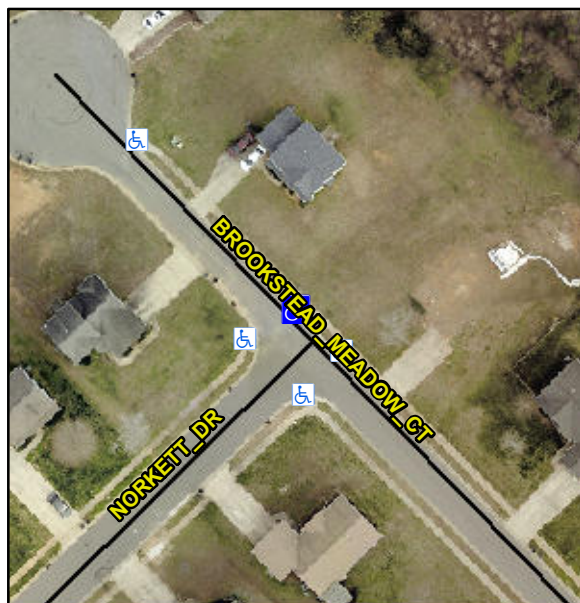
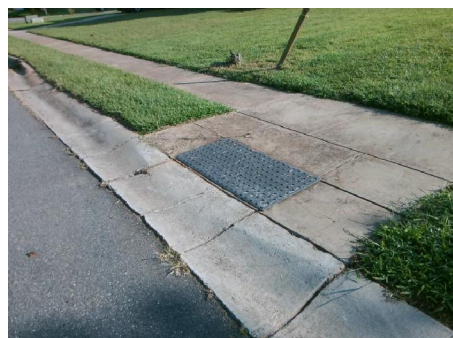
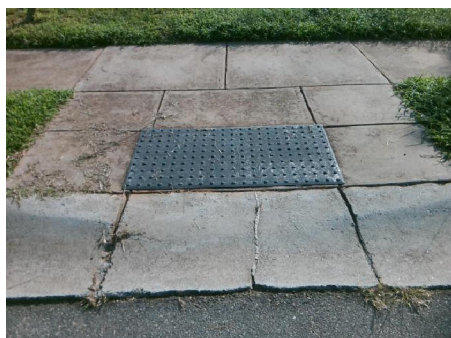
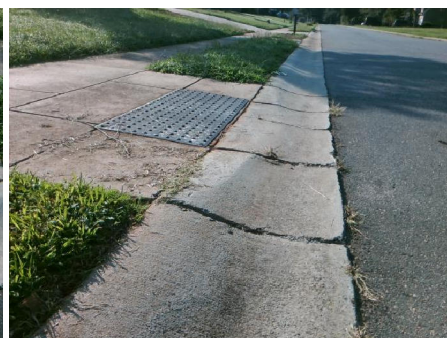
Compliance	Description	Data	Compliance	Description	Data
N/A	Ramp Length (in)	48.5	Yes	Ramp Slope (%)	7.6
No	Ramp Width (in)	44.0	Yes	Ramp XSlope (%)	1.4
N/A	Flare Type LT	N/A	N/A	Flare Type RT	N/A
N/A	Flare Slope LT (%)	N/A	N/A	Flare Slope RT (%)	N/A
N/A	Flare Traversable LT?	N/A	N/A	Flare Traversable RT?	N/A
N/A	Landing Length (in)	N/A	N/A	DWS Provided?	N/A
N/A	Landing Width (in)	N/A	N/A	DWS Contrast?	N/A
N/A	Landing Slope (%)	N/A	N/A	DWS Length (in)	N/A
N/A	Landing X Slope (%)	N/A	N/A	DWS Full Width?	N/A
N/A	Landing Curb? (Y/N)	N/A	N/A	DWS Offset (in)	N/A
N/A	Shared Landing?	N/A			
N/A	Gutter Ponding?	N/A	N/A	Gutter Slope (%)	N/A
N/A	Gutter Lip Ht (in)	0.5	N/A	Gutter X Slope (%)	N/A
N/A	Painted X Walk1?	No	N/A	Painted X Walk2?	N/A
	X Walk 1 Direction	To SW		X Walk 2 Direction	N/A
N/A	X Walk 1 Width (in)	N/A	N/A	X Walk 2 Width (in)	N/A
	X Walk 1 Slope (%)	1.0		X Walk 2 Slope (%)	N/A
	X Walk 1 X Slope (%)	0.4		X Walk 2 X Slope (%)	N/A

N/A	Ramp inside XWalk1?	N/A	N/A	Ramp inside XWalk2?	N/A
	Road Slope (%)	N/A	N/A	Clear Space?	N/A
	Road X Slope (%)	N/A	N/A	Clear Space to XWalk (in)	N/A
N/A	Any Obstructions?	N/A	N/A	Storm Grate/Utility Hazard?	N/A
	Obstruction Type			Storm Grate/Utility Type	
		N/A			N/A
			Yes	Surface Condition? (G/P)	Good

**Remove & Replace Entire Ramp.**

**Not Found, R304.5.1**
