Access Compliance Report

Public Rights-of-Way

(Curb Ramps)

Intersection ID: 30374	Main Street: EASTWAY_CROSSING_DR	Cross Street: EASTWAY_DR	Location: NW
ADA ID: 57DD3662526B	Ramp Type: Directional1	Initial Pass/Fail: Fail	Overall Compliance: No
Codes/Mitigation Info/Possible Solution			Severity Score: 25
			Field Measurements/Component Compliance

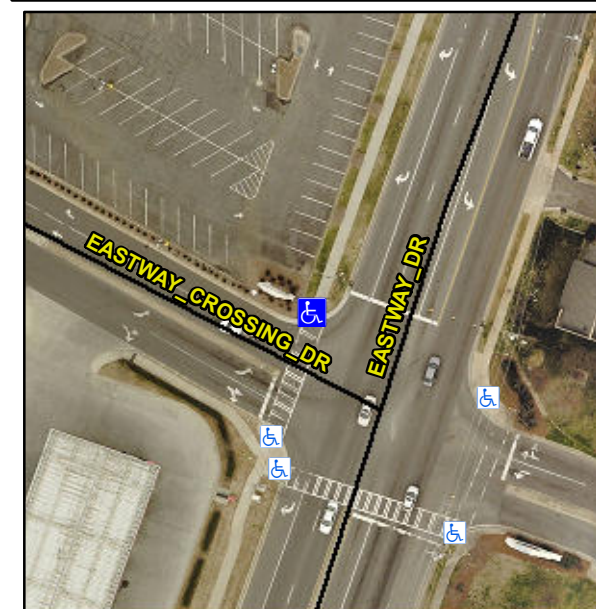
Compliance	Description	Data	Compliance	Description	Data
N/A	Ramp Length (in)	114.0	N/A	Grade Break?	N/A
Yes	Ramp Width (in)	72.5	N/A	Grade Break Slope (%)	0.0
No	Ramp Slope (%)	8.7	N/A	Grade Break XSlope (%)	0.0
No	Ramp XSlope (%)	5.4			
N/A	Flare Type LT	N/A	N/A	Flare Type RT	N/A
N/A	Flare Slope LT (%)	N/A	N/A	Flare Slope RT (%)	0.0
N/A	Flare Traversable LT?	N/A	N/A	Flare Traversable RT?	N/A
N/A	Landing Length (in)	0.0	N/A	DWS Provided?	N/A
N/A	Landing Width (in)	0.0	N/A	DWS Contrast?	N/A
N/A	Landing Slope (%)	0.0	N/A	DWS Length (in)	N/A
N/A	Landing X Slope (%)	0.0	N/A	DWS Full Width?	N/A
N/A	Landing Curb? (Y/N)	N/A	N/A	DWS Offset LT (in)	N/A
N/A	Shared Landing?	N/A	N/A	DWS Offset RT (in)	N/A
N/A	Gutter Ponding?	0.0	N/A	Gutter Slope (%)	N/A
N/A	Gutter Lip Ht (in)	0.0	N/A	Gutter X Slope (%)	N/A
N/A	Painted X Walk1?	Yes		Road Slope (%)	1.4
	X Walk 1 Direction	To S		Road X Slope (%)	0.9
	X Walk 1 Width (in)	117.0		Clear Space?	N/A

X Walk 1 Slope (%)	1.4	N/A	Clear Space to XWalk (in)	N/A
	X Walk 1 X Slope (%)	0.9	N/A	Storm Grate/Utility Hazard?	N/A
N/A	Ramp inside XWalk1?	Yes		Storm Grate/Utility Type	
N/A	Any Obstructions?	N/A			N/A
	Obstruction Type		Yes	Surface Condition? (G/P)	Good
			N/A	Curb Slope (%)	0.3

Possible Solutions:

Remove & Replace Entire Ramp.

R304.2.2, R304.5.3
