# Access Compliance Report

## Public Rights-of-Way

### (Curb Ramps)

Intersection ID: 10023487	Main Street: CIRCUMFERENTIAL_RD	Cross Street: N/A	Location: W
ADA ID: 57E27C5C6292	Ramp Type: PerpDiag	Initial Pass/Fail: Fail	Overall Compliance: No
		Severity Score: 12.5

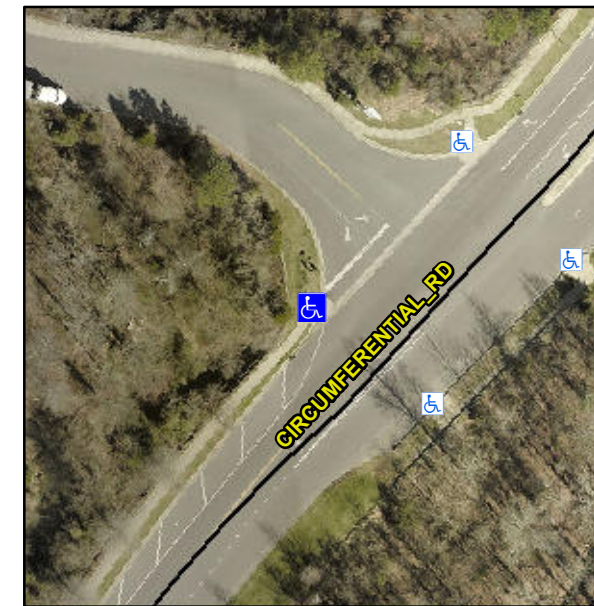
**Not Found, R304.5.3**

Compliance	Description	Data	Compliance	Description	Data
N/A	Ramp Length (in)	85.0	Yes	Ramp Slope (%)	7.1
Yes	Ramp Width (in)	48.0	No	Ramp XSlope (%)	5.8
N/A	Flare Type LT	N/A	N/A	Flare Type RT	N/A
N/A	Flare Slope LT (%)	N/A	N/A	Flare Slope RT (%)	N/A
N/A	Flare Traversable LT?	N/A	N/A	Flare Traversable RT?	N/A
N/A	Landing Length (in)	N/A	N/A	DWS Provided?	N/A
N/A	Landing Width (in)	N/A	N/A	DWS Contrast?	N/A
N/A	Landing Slope (%)	N/A	N/A	DWS Length (in)	N/A
N/A	Landing X Slope (%)	N/A	N/A	DWS Full Width?	N/A
N/A	Landing Curb? (Y/N)	N/A	N/A	DWS Offset (in)	N/A
N/A	Shared Landing?	N/A			
N/A	Gutter Ponding?	N/A	N/A	Gutter Slope (%)	N/A
N/A	Gutter Lip Ht (in)	N/A	N/A	Gutter X Slope (%)	N/A
N/A	Painted X Walk1?	No	N/A	Painted X Walk2?	No
	X Walk 1 Direction	To SE		X Walk 2 Direction	To NE
N/A	X Walk 1 Width (in)	N/A	N/A	X Walk 2 Width (in)	N/A
	X Walk 1 Slope (%)	1.7		X Walk 2 Slope (%)	2.4
	X Walk 1 X Slope (%)	3.0		X Walk 2 X Slope (%)	3.5

N/A	Ramp inside XWalk1?	N/A	N/A	Ramp inside XWalk2?	N/A
	Road Slope (%)	3.8	N/A	Clear Space?	N/A
	Road X Slope (%)	0.4	N/A	Clear Space to XWalk (in)	N/A
N/A	Any Obstructions?	N/A	N/A	Storm Grate/Utility Hazard?	N/A
	Obstruction Type			Storm Grate/Utility Type	
		N/A			N/A
			Yes	Surface Condition? (G/P)	Good

**Remove & Replace Curb Ramp With Two New Directional Ramps or Equivalent.**
