# Access Compliance Report

## Public Rights-of-Way

### (Curb Ramps)

Intersection ID: 12082	Main Street: ALLEN_ST	Cross Street: E_16TH_ST	Location: W
ADA ID: 57F05A16D064	Ramp Type: BlendTrans1	Initial Pass/Fail: Fail	Overall Compliance: No
Severity Score: 33.75			
Codes/Mitigation Info/Possible Solution		Field Measurements/Component Compliance

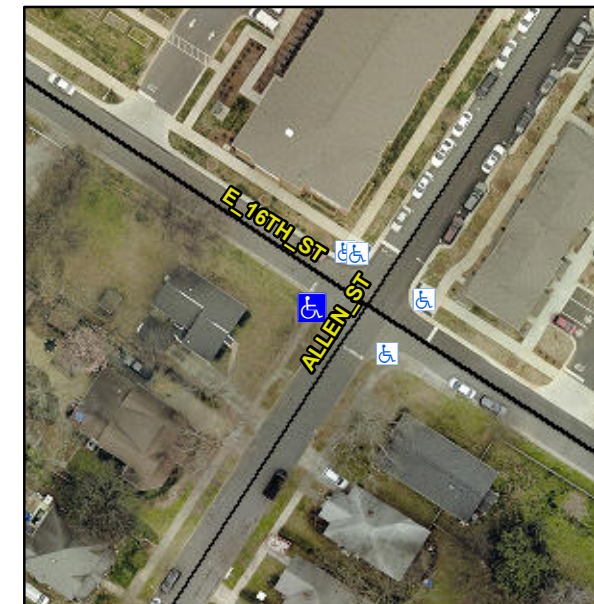
**NO RT SW**

**Not Found, R304.5.1, R304.5.3**

Compliance	Description	Data	Compliance	Description	Data
N/A	Ramp Length (in)	84.5	Yes	BlendTrans Slope (%)	2.5
No	Ramp Width (in)	44.0	No	BlendTrans XSlope (%)	10.3
N/A	Flare Type LT	N/A	N/A	Flare Type RT	N/A
N/A	Flare Slope LT (%)	N/A	N/A	Flare Slope RT (%)	N/A
N/A	Flare Traversable LT?	N/A	N/A	Flare Traversable RT?	N/A
N/A	Landing Length (in)	N/A	N/A	DWS Provided?	N/A
N/A	Landing Width (in)	N/A	N/A	DWS Contrast?	N/A
N/A	Landing Slope (%)	N/A	N/A	DWS Length (in)	N/A
N/A	Landing X Slope (%)	N/A	N/A	DWS Full Width?	N/A
N/A	Landing Curb? (Y/N)	N/A	N/A	DWS Offset (in)	N/A
N/A	Shared Landing?	N/A			
N/A	Gutter Ponding?	N/A	N/A	Gutter Slope (%)	N/A
N/A	Gutter Lip Ht (in)	N/A	N/A	Gutter X Slope (%)	N/A
N/A	Painted X Walk1?	No	N/A	Painted X Walk2?	No
	X Walk 1 Direction	To SE		X Walk 2 Direction	To NE
	X Walk 1 Width (in)	N/A		X Walk 2 Width (in)	N/A
	X Walk 1 Slope (%)	3.6		X Walk 2 Slope (%)	5.5
	X Walk 1 X Slope (%)	5.3		X Walk 2 X Slope (%)	6.6

N/A	Ramp inside XWalk1?	N/A	N/A	Ramp inside XWalk2?	N/A
	Road Slope (%)	8.3		Clear Space?	N/A
	Road X Slope (%)	4.7	N/A	Clear Space to XWalk (in)	N/A
N/A	Any Obstructions?	N/A	N/A	Storm Grate/Utility Hazard?	N/A
	Obstruction Type			Storm Grate/Utility Type	
		N/A			N/A
			Yes	Surface Condition? (G/P)	Good
			No	Curb Slope (%)	23.6

**Remove & Replace Curb Ramp With Two New Directional Ramps or Equivalent.**

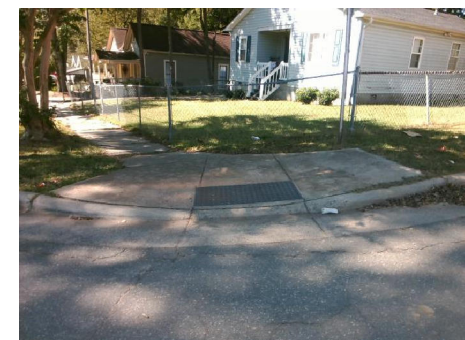
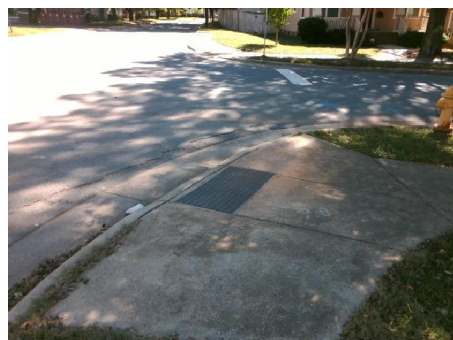
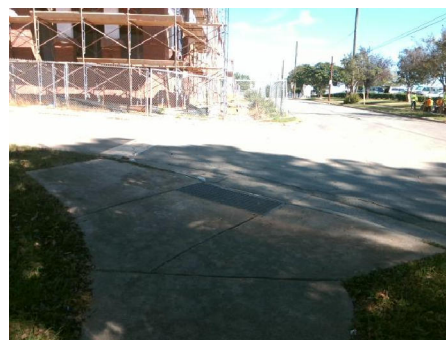
Street 1 Name ALLEN ST  
 Stop Condition-Street 1 StopSign  
 Street 2 Name E 16TH ST  
 Stop Condition-Street 2 StopSign
