# Access Compliance Report

## Public Rights-of-Way

### (Curb Ramps)

Intersection ID: N/A	Main Street: W_W_T_HARRIS_BV	Cross Street: N/A	Location: NE
ADA ID: 57F203438E5D	Ramp Type: PerpDiag	Initial Pass/Fail: Fail	Overall Compliance: No
		Severity Score: 12.5

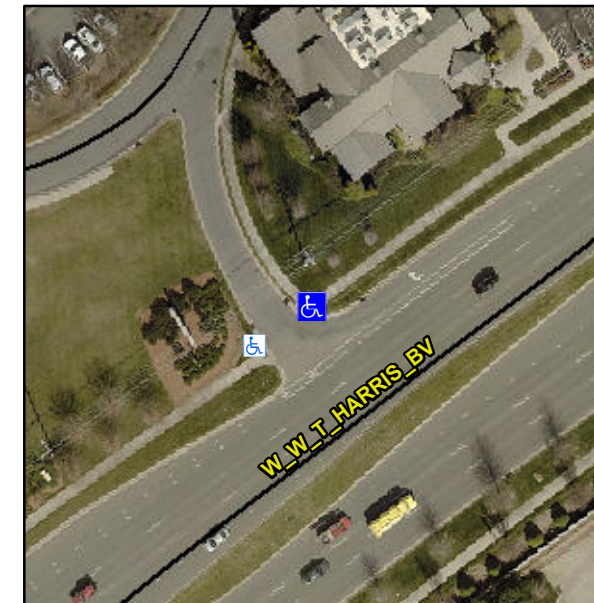
Compliance	Description	Data	Compliance	Description	Data
N/A	Ramp Length (in)	108.0	No	Ramp Slope (%)	11.7
Yes	Ramp Width (in)	48.0	Yes	Ramp XSlope (%)	0.3
N/A	Flare Type LT	N/A	N/A	Flare Type RT	N/A
N/A	Flare Slope LT (%)	N/A	N/A	Flare Slope RT (%)	N/A
N/A	Flare Traversable LT?	No	N/A	Flare Traversable RT?	No
N/A	Landing Length (in)	N/A	N/A	DWS Provided?	N/A
N/A	Landing Width (in)	N/A	N/A	DWS Contrast?	N/A
N/A	Landing Slope (%)	N/A	N/A	DWS Length (in)	N/A
N/A	Landing X Slope (%)	N/A	N/A	DWS Full Width?	N/A
N/A	Landing Curb? (Y/N)	N/A	N/A	DWS Offset (in)	N/A
N/A	Shared Landing?	N/A			
N/A	Gutter Ponding?	N/A	N/A	Gutter Slope (%)	N/A
N/A	Gutter Lip Ht (in)	N/A	N/A	Gutter X Slope (%)	N/A
N/A	Painted X Walk1?	No	N/A	Painted X Walk2?	No
	X Walk 1 Direction	To SW		X Walk 2 Direction	To S
N/A	X Walk 1 Width (in)	N/A	N/A	X Walk 2 Width (in)	N/A
	X Walk 1 Slope (%)	4.3		X Walk 2 Slope (%)	0.3
	X Walk 1 X Slope (%)	2.3		X Walk 2 X Slope (%)	6.4

N/A	Ramp inside XWalk1?	N/A	N/A	Ramp inside XWalk2?	N/A
	Road Slope (%)	1.3	N/A	Clear Space?	N/A
	Road X Slope (%)	6.9	N/A	Clear Space to XWalk (in)	N/A
N/A	Any Obstructions?	N/A	N/A	Storm Grate/Utility Hazard?	N/A
	Obstruction Type			Storm Grate/Utility Type	
		N/A			N/A
			Yes	Surface Condition? (G/P)	Good

**Remove & Replace Curb Ramp With Two New Directional Ramps or Equivalent.**

**R304.2.2**
