Access Compliance Report

Public Rights-of-Way

(Curb Ramps)

Intersection ID: 10025561	Main Street: E_W_T_HARRIS_BV	Cross Street: IDLEWILD_RD_NORTH	Location: SE
ADA ID: 57FF6E2C2B68	Ramp Type: Perp	Initial Pass/Fail: Fail	Overall Compliance: No
Codes/Mitigation Info/Possible Solution		Field Measurements/Component Compliance	
Severity Score: 21.25

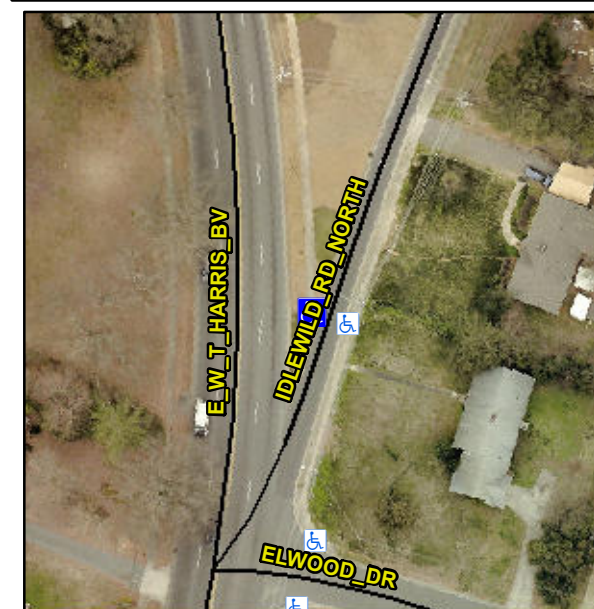
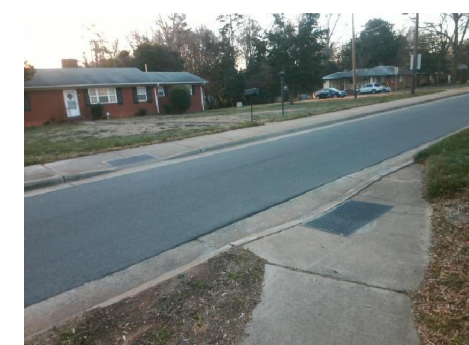
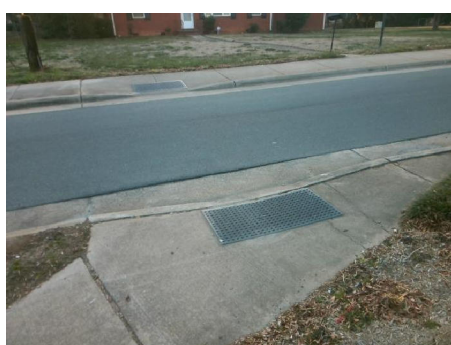
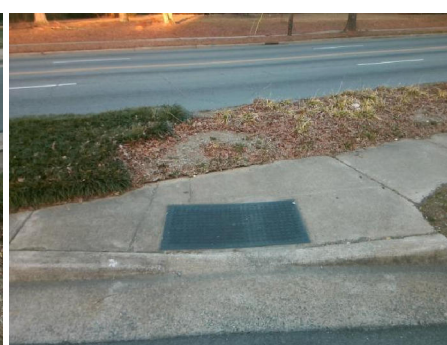
Not Found, R304.5.1, R304.5.3

Compliance	Description	Data	Compliance	Description	Data
N/A	Ramp Length (in)	46.0	Yes	Ramp Slope (%)	5.4
No	Ramp Width (in)	40.0	No	Ramp XSlope (%)	5.3
N/A	Flare Type LT	N/A	N/A	Flare Type RT	N/A
N/A	Flare Slope LT (%)	N/A	N/A	Flare Slope RT (%)	N/A
N/A	Flare Traversable LT?	N/A	N/A	Flare Traversable RT?	N/A
N/A	Landing Length (in)	N/A	N/A	DWS Provided?	N/A
N/A	Landing Width (in)	N/A	N/A	DWS Contrast?	N/A
N/A	Landing Slope (%)	N/A	N/A	DWS Length (in)	N/A
N/A	Landing X Slope (%)	N/A	N/A	DWS Full Width?	N/A
N/A	Landing Curb? (Y/N)	N/A	N/A	DWS Offset (in)	N/A
N/A	Shared Landing?	N/A			
N/A	Gutter Ponding?	N/A	N/A	Gutter Slope (%)	N/A
N/A	Gutter Lip Ht (in)	N/A	N/A	Gutter X Slope (%)	N/A
N/A	Painted X Walk1?	No	N/A	Painted X Walk2?	N/A
	X Walk 1 Direction	To SE		X Walk 2 Direction	N/A
N/A	X Walk 1 Width (in)	N/A	N/A	X Walk 2 Width (in)	N/A
	X Walk 1 Slope (%)	1.1		X Walk 2 Slope (%)	N/A
	X Walk 1 X Slope (%)	2.4		X Walk 2 X Slope (%)	N/A

N/A	Ramp inside XWalk1?	N/A	N/A	Ramp inside XWalk2?	N/A
	Road Slope (%)	N/A	N/A	Clear Space?	N/A
	Road X Slope (%)	N/A	N/A	Clear Space to XWalk (in)	N/A
N/A	Any Obstructions?	N/A	N/A	Storm Grate/Utility Hazard?	N/A
	Obstruction Type			Storm Grate/Utility Type	
		N/A			N/A
			Yes	Surface Condition? (G/P)	Good

Remove & Replace Entire Ramp.
