Access Compliance Report

Public Rights-of-Way

(Curb Ramps)

Intersection ID: 13382	Main Street: E_CATHERINE_ST	Cross Street: S_COLLEGE_ST	Location: NE
ADA ID: 5801E645440F	Ramp Type: Perp	Initial Pass/Fail: Fail	Overall Compliance: No
Severity Score: 13.75			
Codes/Mitigation Info/Possible Solution		Field Measurements/Component Compliance

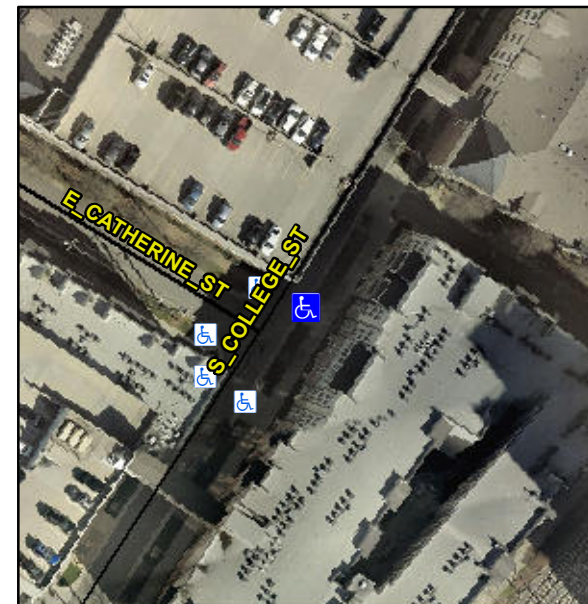
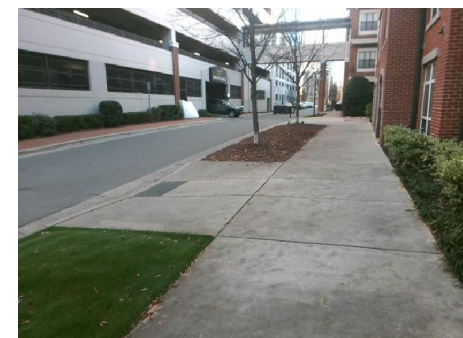
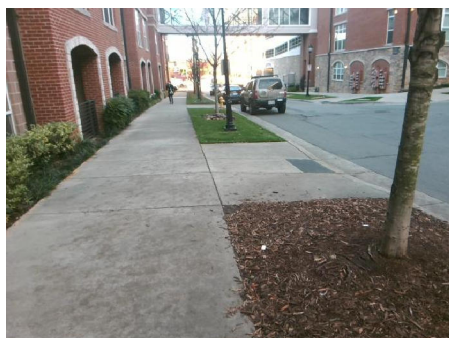
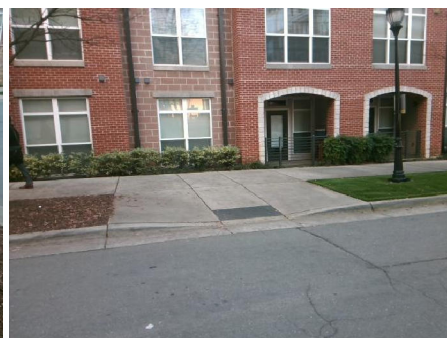
Not Found, R304.2.2

Compliance	Description	Data	Compliance	Description	Data
N/A	Ramp Length (in)	94.0	No	Ramp Slope (%)	8.9
Yes	Ramp Width (in)	48.0	Yes	Ramp XSlope (%)	4.2
N/A	Flare Type LT	N/A	N/A	Flare Type RT	N/A
N/A	Flare Slope LT (%)	N/A	N/A	Flare Slope RT (%)	N/A
N/A	Flare Traversable LT?	N/A	N/A	Flare Traversable RT?	N/A
N/A	Landing Length (in)	N/A	N/A	DWS Provided?	N/A
N/A	Landing Width (in)	N/A	N/A	DWS Contrast?	N/A
N/A	Landing Slope (%)	N/A	N/A	DWS Length (in)	N/A
N/A	Landing X Slope (%)	N/A	N/A	DWS Full Width?	N/A
N/A	Landing Curb? (Y/N)	N/A	N/A	DWS Offset (in)	N/A
N/A	Shared Landing?	N/A			
N/A	Gutter Ponding?	N/A	N/A	Gutter Slope (%)	N/A
N/A	Gutter Lip Ht (in)	N/A	N/A	Gutter X Slope (%)	N/A
N/A	Painted X Walk1?	No	N/A	Painted X Walk2?	N/A
	X Walk 1 Direction	To NW		X Walk 2 Direction	N/A
N/A	X Walk 1 Width (in)	N/A	N/A	X Walk 2 Width (in)	N/A
	X Walk 1 Slope (%)	0.3		X Walk 2 Slope (%)	N/A
	X Walk 1 X Slope (%)	5.0		X Walk 2 X Slope (%)	N/A

N/A	Ramp inside XWalk1?	N/A	N/A	Ramp inside XWalk2?	N/A
	Road Slope (%)	N/A	N/A	Clear Space?	N/A
	Road X Slope (%)	N/A	N/A	Clear Space to XWalk (in)	N/A
N/A	Any Obstructions?	N/A	N/A	Storm Grate/Utility Hazard?	N/A
	Obstruction Type			Storm Grate/Utility Type	
		N/A			N/A
			Yes	Surface Condition? (G/P)	Good

Remove & Replace Entire Ramp.

Total Cost: \$ 1850.00
