Access Compliance Report

Public Rights-of-Way

(Curb Ramps)

| Intersection ID: 19443 | Main Street: ECHODALE_DR | Cross Street: ELLENDALE_DR | Location: NE |

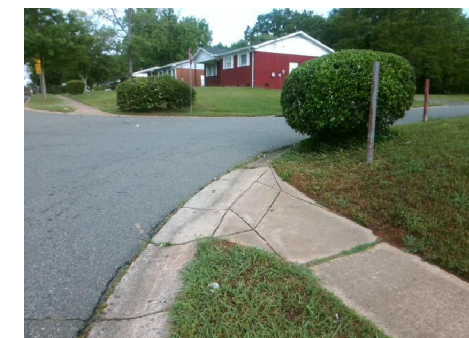
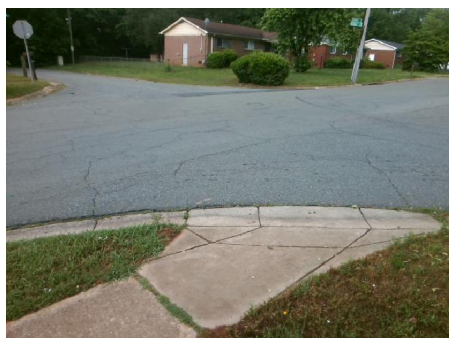
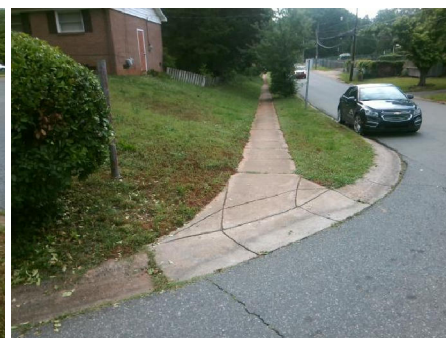
| ADA ID: 581842615298 | Ramp Type: Directional1 | Initial Pass/Fail: Fail | Overall Compliance: No |
| Severity Score: 33.75 | | | |

| Compliance | Description | Data | Compliance | Description | Data |
|---|---|---|---|---|---|
| No | Ramp Width (in) | 38.0 | N/A | Grade Break Slope (%) | 0.0 |
| No | Ramp XSlope (%) | 7.2 | | | |

Remove & Replace Entire Ramp.

R304.5.1, R304.5.3

\$ 1600.00
