Access Compliance Report

Public Rights-of-Way

(Curb Ramps)

Intersection ID: 3980	Main Street: GANNETT_DR	Cross Street: STONY_PATH_DR	Location: S
ADA ID: 581AD5A6A168	Ramp Type: Perp	Initial Pass/Fail: Fail	Overall Compliance: No
Severity Score: 22.5			
Codes/Mitigation Info/Possible Solution		Field Measurements/Component Compliance

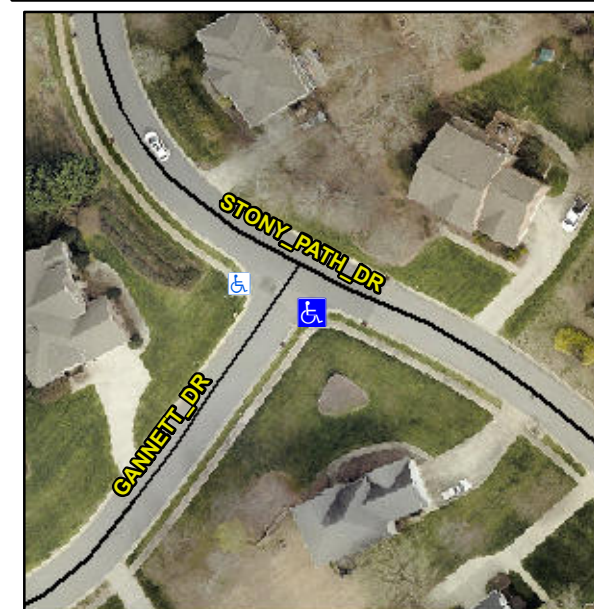
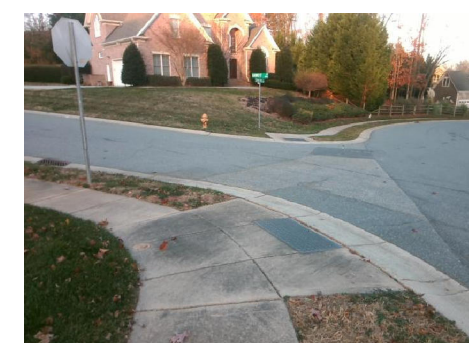
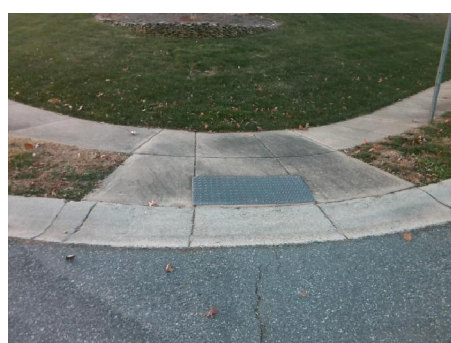
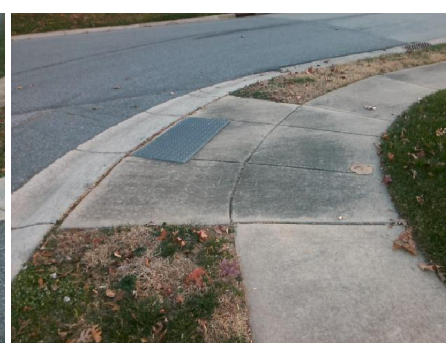
Not Found, R304.5.1, R304.2.2, R304.5.3

Compliance	Description	Data	Compliance	Description	Data
N/A	Ramp Length (in)	49.5	No	Ramp Slope (%)	9.6
No	Ramp Width (in)	40.0	No	Ramp XSlope (%)	4.6
N/A	Flare Type LT	N/A	N/A	Flare Type RT	N/A
N/A	Flare Slope LT (%)	N/A	N/A	Flare Slope RT (%)	N/A
N/A	Flare Traversable LT?	N/A	N/A	Flare Traversable RT?	N/A
N/A	Landing Length (in)	N/A	N/A	DWS Provided?	N/A
N/A	Landing Width (in)	N/A	N/A	DWS Contrast?	N/A
N/A	Landing Slope (%)	N/A	N/A	DWS Length (in)	N/A
N/A	Landing X Slope (%)	N/A	N/A	DWS Full Width?	N/A
N/A	Landing Curb? (Y/N)	N/A	N/A	DWS Offset (in)	N/A
N/A	Shared Landing?	N/A			
N/A	Gutter Ponding?	N/A	N/A	Gutter Slope (%)	N/A
N/A	Gutter Lip Ht (in)	N/A	N/A	Gutter X Slope (%)	N/A
N/A	Painted X Walk1?	No	N/A	Painted X Walk2?	N/A
	X Walk 1 Direction	To NW		X Walk 2 Direction	N/A
N/A	X Walk 1 Width (in)	N/A	N/A	X Walk 2 Width (in)	N/A
	X Walk 1 Slope (%)	7.1		X Walk 2 Slope (%)	N/A
	X Walk 1 X Slope (%)	0.9		X Walk 2 X Slope (%)	N/A

N/A	Ramp inside XWalk1?	N/A	N/A	Ramp inside XWalk2?	N/A
	Road Slope (%)	N/A	N/A	Clear Space?	N/A
	Road X Slope (%)	N/A	N/A	Clear Space to XWalk (in)	N/A
N/A	Any Obstructions?	N/A	N/A	Storm Grate/Utility Hazard?	N/A
	Obstruction Type			Storm Grate/Utility Type	
		N/A			N/A
			Yes	Surface Condition? (G/P)	Good

Remove & Replace Entire Ramp.
