# Access Compliance Report

## Public Rights-of-Way

### (Curb Ramps)

Intersection ID: 8258	Main Street: ENGLEHARDT_ST	Cross Street: ENGLISH_DR	Location: SE
ADA ID: 581E7B869E7C	Ramp Type: Perp	Initial Pass/Fail: Fail	Overall Compliance: No
Severity Score: 13.75			
Codes/Mitigation Info/Possible Solution		Field Measurements/Component Compliance

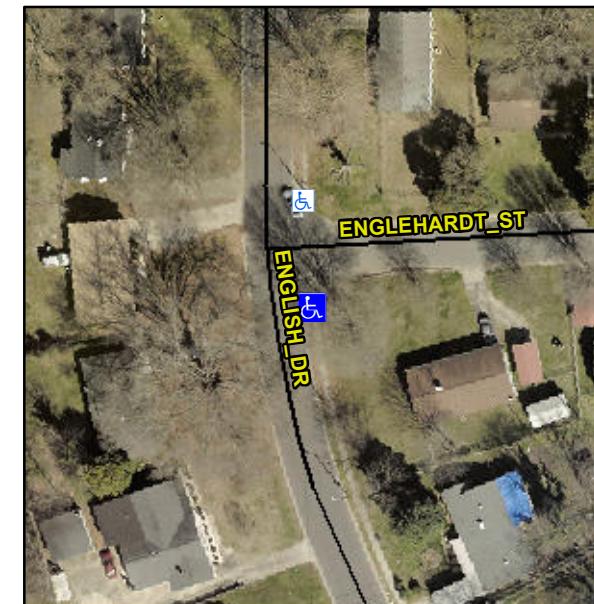
**Not Found, R304.2.2, R304.5.3**

Compliance	Description	Data	Compliance	Description	Data
N/A	Ramp Length (in)	30.0	No	Ramp Slope (%)	10.0
Yes	Ramp Width (in)	48.0	No	Ramp XSlope (%)	4.3
N/A	Flare Type LT	N/A	N/A	Flare Type RT	N/A
N/A	Flare Slope LT (%)	N/A	N/A	Flare Slope RT (%)	N/A
N/A	Flare Traversable LT?	N/A	N/A	Flare Traversable RT?	N/A
N/A	Landing Length (in)	N/A	N/A	DWS Provided?	N/A
N/A	Landing Width (in)	N/A	N/A	DWS Contrast?	N/A
N/A	Landing Slope (%)	N/A	N/A	DWS Length (in)	N/A
N/A	Landing X Slope (%)	N/A	N/A	DWS Full Width?	N/A
N/A	Landing Curb? (Y/N)	N/A	N/A	DWS Offset (in)	N/A
N/A	Shared Landing?	N/A			
N/A	Gutter Ponding?	N/A	N/A	Gutter Slope (%)	N/A
N/A	Gutter Lip Ht (in)	N/A	N/A	Gutter X Slope (%)	N/A
N/A	Painted X Walk1?	No	N/A	Painted X Walk2?	N/A
	X Walk 1 Direction	To N		X Walk 2 Direction	N/A
N/A	X Walk 1 Width (in)	N/A	N/A	X Walk 2 Width (in)	N/A
	X Walk 1 Slope (%)	0.4		X Walk 2 Slope (%)	N/A
	X Walk 1 X Slope (%)	2.0		X Walk 2 X Slope (%)	N/A

N/A	Ramp inside XWalk1?	N/A	N/A	Ramp inside XWalk2?	N/A
	Road Slope (%)	N/A	N/A	Clear Space?	N/A
	Road X Slope (%)	N/A	N/A	Clear Space to XWalk (in)	N/A
N/A	Any Obstructions?	N/A	N/A	Storm Grate/Utility Hazard?	N/A
	Obstruction Type			Storm Grate/Utility Type	
		N/A			N/A
		Yes		Surface Condition? (G/P)	Good

**Remove & Replace Entire Ramp.**

Total Cost: \$ 1850.00
