# Access Compliance Report

## Public Rights-of-Way

### (Curb Ramps)

| Intersection ID: 28369 | Main Street: TONAWANDA_DR | Cross Street: BURNSIDE_LN | Location: S |

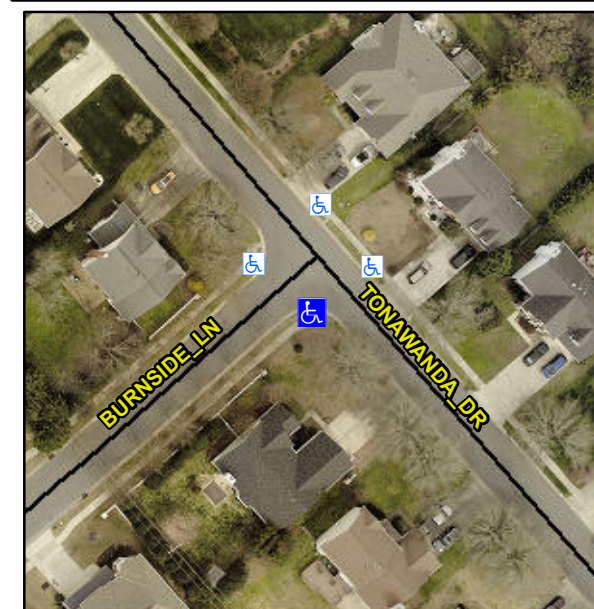
**NO LT SW**

**Not Found, R304.5.3, R304.2.1**

| Compliance | Description | Data | Compliance | Description | Data |
|---|---|---|---|---|---|
| Yes | Ramp Width (in) | 48.0 | No | BlendTrans XSlope (%) | 2.4 |
| No | Landing Length (in) | 47.0 | Yes | DWS Provided? | Yes |
| | | | No | Curb Slope (%) | 8.9 |

**Remove & Replace Curb Ramp With Two New Directional Ramps or Equivalent.**

Total Cost: \$ 3200.00

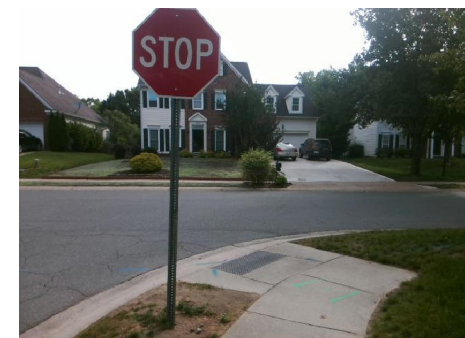
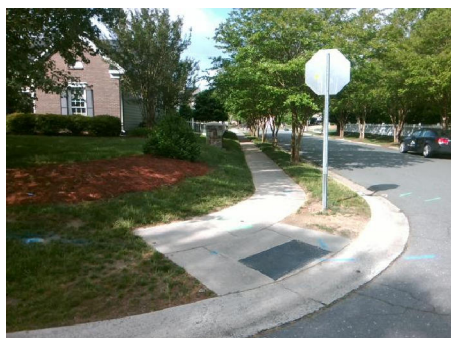
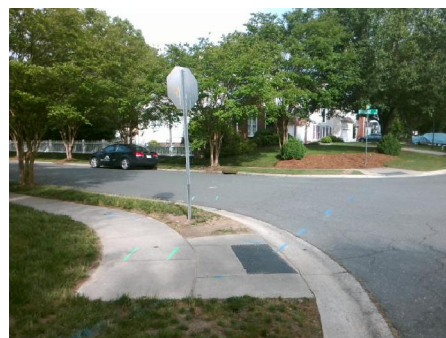
Street 1 Name TONAWANDA DR  
 Stop Condition-Street 1 None  
 Street 2 Name BURNSIDE LN  
 Stop Condition-Street 2 StopSign
