Access Compliance Report

Public Rights-of-Way

(Curb Ramps)

Intersection ID: 17504	Main Street: CORINTHIAN_PL	Cross Street: WALKER_RD	Location: SE
ADA ID: 582110C6AB65	Ramp Type: PerpDiag	Initial Pass/Fail: Fail	Overall Compliance: No
		Severity Score: 55

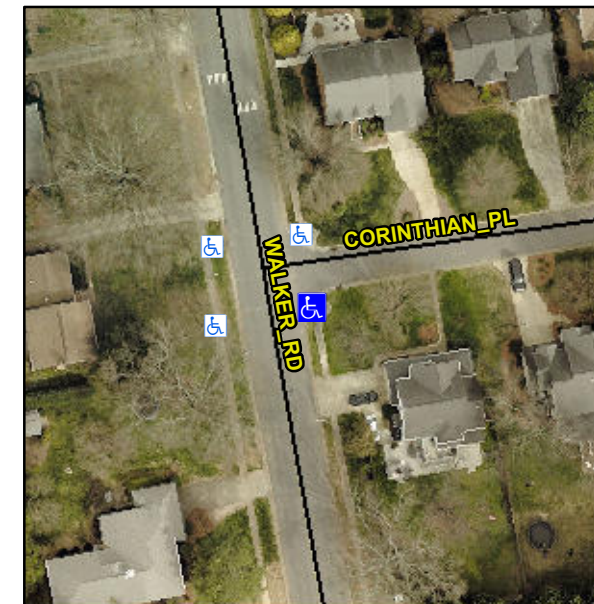
Not Found, R304.5.1, R304.2.2, R304.5.3

Compliance	Description	Data	Compliance	Description	Data
N/A	Ramp Length (in)	48.0	No	Ramp Slope (%)	10.4
No	Ramp Width (in)	34.0	No	Ramp XSlope (%)	7.7
N/A	Flare Type LT	N/A	N/A	Flare Type RT	N/A
N/A	Flare Slope LT (%)	N/A	N/A	Flare Slope RT (%)	N/A
N/A	Flare Traversable LT?	N/A	N/A	Flare Traversable RT?	N/A
N/A	Landing Length (in)	N/A	N/A	DWS Provided?	N/A
N/A	Landing Width (in)	N/A	N/A	DWS Contrast?	N/A
N/A	Landing Slope (%)	N/A	N/A	DWS Length (in)	N/A
N/A	Landing X Slope (%)	N/A	N/A	DWS Full Width?	N/A
N/A	Landing Curb? (Y/N)	N/A	N/A	DWS Offset (in)	N/A
N/A	Shared Landing?	N/A			
N/A	Gutter Ponding?	N/A	N/A	Gutter Slope (%)	N/A
N/A	Gutter Lip Ht (in)	N/A	N/A	Gutter X Slope (%)	N/A
N/A	Painted X Walk1?	No	N/A	Painted X Walk2?	No
	X Walk 1 Direction	To N		X Walk 2 Direction	To W
N/A	X Walk 1 Width (in)	N/A	N/A	X Walk 2 Width (in)	N/A
	X Walk 1 Slope (%)	2.8		X Walk 2 Slope (%)	6.8
	X Walk 1 X Slope (%)	6.0		X Walk 2 X Slope (%)	2.5

N/A	Ramp inside XWalk1?	N/A	N/A	Ramp inside XWalk2?	N/A
	Road Slope (%)	7.0	N/A	Clear Space?	N/A
	Road X Slope (%)	1.4	N/A	Clear Space to XWalk (in)	N/A
N/A	Any Obstructions?	N/A	N/A	Storm Grate/Utility Hazard?	N/A
	Obstruction Type			Storm Grate/Utility Type	
		N/A			N/A
			Yes	Surface Condition? (G/P)	Good

Remove & Replace Curb Ramp With Two New Directional Ramps or Equivalent.

Total Cost: \$ 3200.00
