Access Compliance Report

Public Rights-of-Way

(Curb Ramps)

Intersection ID: 47817	Main Street: DUSKY_PINE_DR	Cross Street: ROCKMOOR_RIDGE_RD	Location: NE
ADA ID: 5822E9727C2A	Ramp Type: PerpDiag	Initial Pass/Fail: Fail	Overall Compliance: No
Severity Score: 21.25			
Codes/Mitigation Info/Possible Solution		Field Measurements/Component Compliance

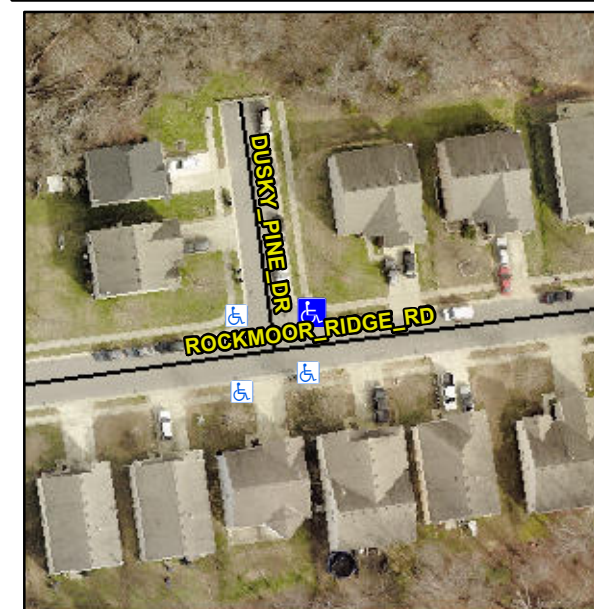
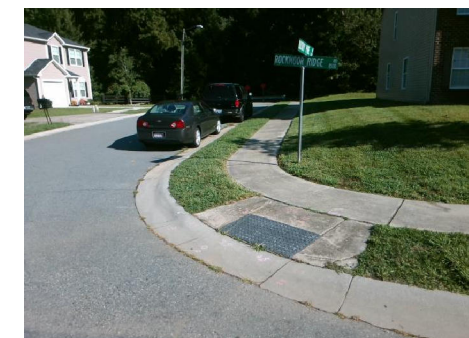
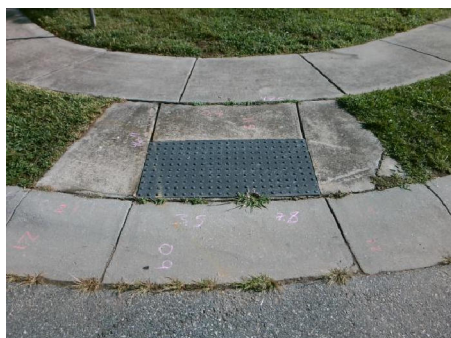
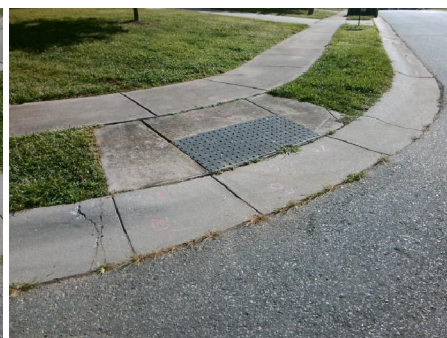
Not Found, R304.5.1, R304.2.2

Compliance	Description	Data	Compliance	Description	Data
N/A	Ramp Length (in)	46.0	No	Ramp Slope (%)	11.5
No	Ramp Width (in)	47.5	Yes	Ramp XSlope (%)	0.4
N/A	Flare Type LT	N/A	N/A	Flare Type RT	N/A
N/A	Flare Slope LT (%)	N/A	N/A	Flare Slope RT (%)	N/A
N/A	Flare Traversable LT?	N/A	N/A	Flare Traversable RT?	N/A
N/A	Landing Length (in)	N/A	N/A	DWS Provided?	N/A
N/A	Landing Width (in)	N/A	N/A	DWS Contrast?	N/A
N/A	Landing Slope (%)	N/A	N/A	DWS Length (in)	N/A
N/A	Landing X Slope (%)	N/A	N/A	DWS Full Width?	N/A
N/A	Landing Curb? (Y/N)	N/A	N/A	DWS Offset (in)	N/A
N/A	Shared Landing?	N/A			
N/A	Gutter Ponding?	N/A	N/A	Gutter Slope (%)	N/A
N/A	Gutter Lip Ht (in)	N/A	N/A	Gutter X Slope (%)	N/A
N/A	Painted X Walk1?	No	N/A	Painted X Walk2?	No
	X Walk 1 Direction	To W		X Walk 2 Direction	To S
N/A	X Walk 1 Width (in)	N/A	N/A	X Walk 2 Width (in)	N/A
	X Walk 1 Slope (%)	2.1		X Walk 2 Slope (%)	1.2
	X Walk 1 X Slope (%)	2.1		X Walk 2 X Slope (%)	1.9

N/A	Ramp inside XWalk1?	N/A	N/A	Ramp inside XWalk2?	N/A
	Road Slope (%)	0.9	N/A	Clear Space?	N/A
	Road X Slope (%)	3.5	N/A	Clear Space to XWalk (in)	N/A
N/A	Any Obstructions?	N/A	N/A	Storm Grate/Utility Hazard?	N/A
	Obstruction Type			Storm Grate/Utility Type	
		N/A			N/A
		Yes		Surface Condition? (G/P)	Good

Remove & Replace Curb Ramp With Two New Directional Ramps or Equivalent.
