# Access Compliance Report

## Public Rights-of-Way

### (Curb Ramps)

Intersection ID: 28154	Main Street: AUTUMN_APPLAUSE_DR	Cross Street: WILLOW_TREE_LN	Location: SW
ADA ID: 5825A5A00990	Ramp Type: BlendTrans1	Initial Pass/Fail: Fail	Overall Compliance: No
Codes/Mitigation Info/Possible Solution		Field Measurements/Component Compliance	
Severity Score: 17.5

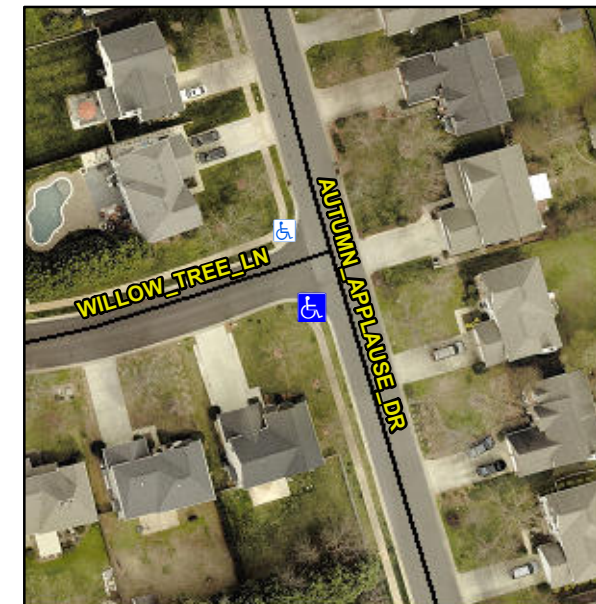
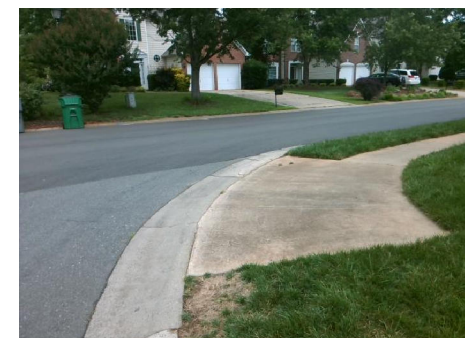
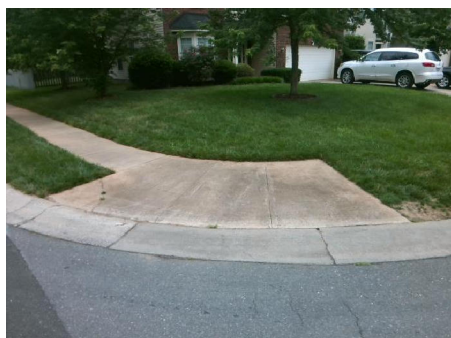
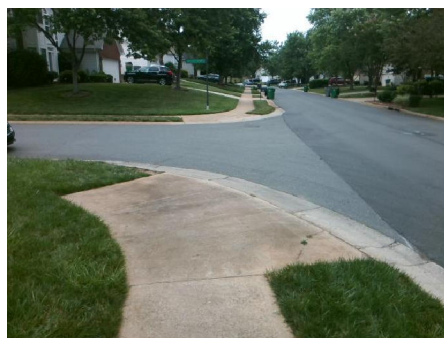
**Not Found, R304.5.1**

Compliance	Description	Data	Compliance	Description	Data
N/A	Ramp Length (in)	98.0	Yes	BlendTrans Slope (%)	4.5
No	Ramp Width (in)	33.0	Yes	BlendTrans XSlope (%)	1.0
N/A	Flare Type LT	N/A	N/A	Flare Type RT	N/A
N/A	Flare Slope LT (%)	N/A	N/A	Flare Slope RT (%)	N/A
N/A	Flare Traversable LT?	N/A	N/A	Flare Traversable RT?	N/A
N/A	Landing Length (in)	N/A	N/A	DWS Provided?	N/A
N/A	Landing Width (in)	N/A	N/A	DWS Contrast?	N/A
N/A	Landing Slope (%)	N/A	N/A	DWS Length (in)	N/A
N/A	Landing X Slope (%)	N/A	N/A	DWS Full Width?	N/A
N/A	Landing Curb? (Y/N)	N/A	N/A	DWS Offset (in)	N/A
N/A	Shared Landing?	N/A			
N/A	Gutter Ponding?	N/A	N/A	Gutter Slope (%)	N/A
N/A	Gutter Lip Ht (in)	N/A	N/A	Gutter X Slope (%)	N/A
N/A	Painted X Walk1?	No	N/A	Painted X Walk2?	No
	X Walk 1 Direction	To NE		X Walk 2 Direction	To NW
	X Walk 1 Width (in)	N/A		X Walk 2 Width (in)	N/A
	X Walk 1 Slope (%)	3.2		X Walk 2 Slope (%)	1.4
	X Walk 1 X Slope (%)	1.5		X Walk 2 X Slope (%)	2.9

N/A	Ramp inside XWalk1?	N/A	N/A	Ramp inside XWalk2?	N/A
	Road Slope (%)	0.2		Clear Space?	N/A
	Road X Slope (%)	7.7	N/A	Clear Space to XWalk (in)	N/A
N/A	Any Obstructions?	N/A	N/A	Storm Grate/Utility Hazard?	N/A
	Obstruction Type			Storm Grate/Utility Type	
		N/A			N/A
			Yes	Surface Condition? (G/P)	Good
			No	Curb Slope (%)	19.9

**Remove & Replace Curb Ramp With Two New Directional Ramps or Equivalent.**
