Access Compliance Report

Public Rights-of-Way

(Curb Ramps)

Intersection ID: 10337	Main Street: E_36TH_ST	Cross Street: SPENCER_ST	Location: E
ADA ID: 58416EA6B2C4	Ramp Type: PerpDiag	Initial Pass/Fail: Fail	Overall Compliance: No
		Severity Score: 8.75

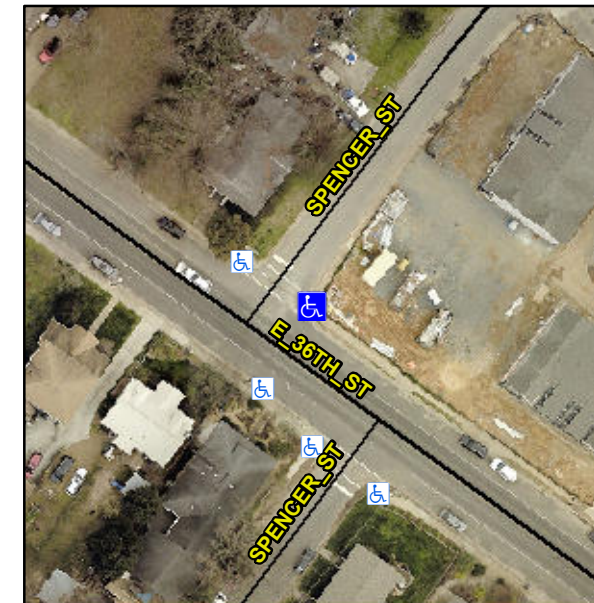
Not Found, R304.5.1

Compliance	Description	Data	Compliance	Description	Data
N/A	Ramp Length (in)	60.0	Yes	Ramp Slope (%)	7.6
No	Ramp Width (in)	47.5	Yes	Ramp XSlope (%)	0.6
N/A	Flare Type LT	N/A	N/A	Flare Type RT	N/A
N/A	Flare Slope LT (%)	N/A	N/A	Flare Slope RT (%)	N/A
N/A	Flare Traversable LT?	N/A	N/A	Flare Traversable RT?	N/A
N/A	Landing Length (in)	N/A	N/A	DWS Provided?	N/A
N/A	Landing Width (in)	N/A	N/A	DWS Contrast?	N/A
N/A	Landing Slope (%)	N/A	N/A	DWS Length (in)	N/A
N/A	Landing X Slope (%)	N/A	N/A	DWS Full Width?	N/A
N/A	Landing Curb? (Y/N)	N/A	N/A	DWS Offset (in)	N/A
N/A	Shared Landing?	N/A			
N/A	Gutter Ponding?	N/A	N/A	Gutter Slope (%)	N/A
N/A	Gutter Lip Ht (in)	N/A	N/A	Gutter X Slope (%)	N/A
N/A	Painted X Walk1?	Yes	N/A	Painted X Walk2?	No
	X Walk 1 Direction	To NW		X Walk 2 Direction	To SW
N/A	X Walk 1 Width (in)	113.0	N/A	X Walk 2 Width (in)	N/A
	X Walk 1 Slope (%)	1.4		X Walk 2 Slope (%)	1.8
	X Walk 1 X Slope (%)	0.0		X Walk 2 X Slope (%)	0.0

Remove & Replace Curb Ramp With Two New Directional Ramps or Equivalent.
