Access Compliance Report

Public Rights-of-Way

(Curb Ramps)

Intersection ID: 44907	Main Street: OAK_DR	Cross Street: OAKWINDS_CT	Location: SE
ADA ID: 58463D74BD2E	Ramp Type: PerpDiag	Initial Pass/Fail: Fail	Overall Compliance: No
Severity Score: 21.25			
Codes/Mitigation Info/Possible Solution		Field Measurements/Component Compliance

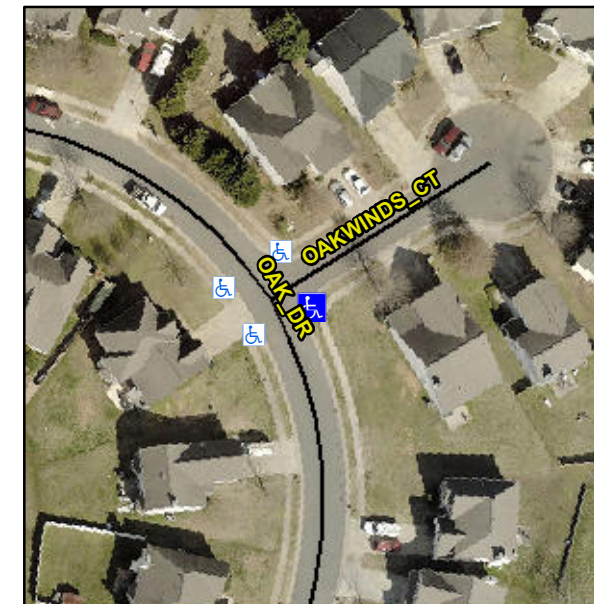
Not Found, R304.5.1, R304.2.2

Compliance	Description	Data	Compliance	Description	Data
N/A	Ramp Length (in)	47.0	No	Ramp Slope (%)	11.0
No	Ramp Width (in)	37.0	Yes	Ramp XSlope (%)	0.9
N/A	Flare Type LT	N/A	N/A	Flare Type RT	N/A
N/A	Flare Slope LT (%)	N/A	N/A	Flare Slope RT (%)	N/A
N/A	Flare Traversable LT?	N/A	N/A	Flare Traversable RT?	N/A
N/A	Landing Length (in)	N/A	N/A	DWS Provided?	N/A
N/A	Landing Width (in)	N/A	N/A	DWS Contrast?	N/A
N/A	Landing Slope (%)	N/A	N/A	DWS Length (in)	N/A
N/A	Landing X Slope (%)	N/A	N/A	DWS Full Width?	N/A
N/A	Landing Curb? (Y/N)	N/A	N/A	DWS Offset (in)	N/A
N/A	Shared Landing?	N/A			
N/A	Gutter Ponding?	N/A	N/A	Gutter Slope (%)	N/A
N/A	Gutter Lip Ht (in)	N/A	N/A	Gutter X Slope (%)	N/A
N/A	Painted X Walk1?	No	N/A	Painted X Walk2?	No
	X Walk 1 Direction	To NW		X Walk 2 Direction	To SW
N/A	X Walk 1 Width (in)	N/A	N/A	X Walk 2 Width (in)	N/A
	X Walk 1 Slope (%)	1.2		X Walk 2 Slope (%)	2.5
	X Walk 1 X Slope (%)	2.3		X Walk 2 X Slope (%)	1.9

N/A	Ramp inside XWalk1?	N/A	N/A	Ramp inside XWalk2?	N/A
	Road Slope (%)	0.7	N/A	Clear Space?	N/A
	Road X Slope (%)	3.4	N/A	Clear Space to XWalk (in)	N/A
N/A	Any Obstructions?	N/A	N/A	Storm Grate/Utility Hazard?	N/A
	Obstruction Type			Storm Grate/Utility Type	
		N/A			N/A
			Yes	Surface Condition? (G/P)	Good

Possible Solutions:

Remove & Replace Curb Ramp With Two New Directional Ramps or Equivalent.
