# Access Compliance Report

## Public Rights-of-Way

### (Curb Ramps)

Intersection ID: 21027	Main Street: CORONATION_BV	Cross Street: N/A	Location: SW
ADA ID: 584A44830E9F	Ramp Type: PerpDiag	Initial Pass/Fail: Fail	Overall Compliance: No
Severity Score: 37.5			
Codes/Mitigation Info/Possible Solution		Field Measurements/Component Compliance

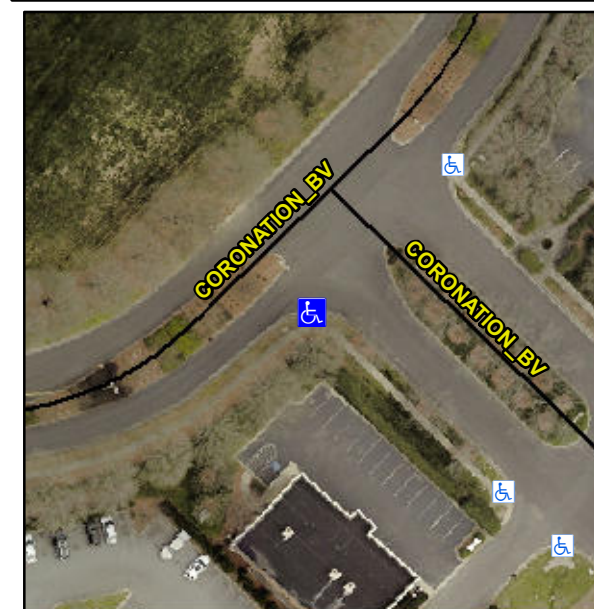
**Not Found, R304.2.2, R304.5.3**

Compliance	Description	Data	Compliance	Description	Data
N/A	Ramp Length (in)	72.0	No	Ramp Slope (%)	9.9
Yes	Ramp Width (in)	48.0	No	Ramp XSlope (%)	13.3
N/A	Flare Type LT	N/A	N/A	Flare Type RT	N/A
N/A	Flare Slope LT (%)	N/A	N/A	Flare Slope RT (%)	N/A
N/A	Flare Traversable LT?	N/A	N/A	Flare Traversable RT?	N/A
N/A	Landing Length (in)	N/A	N/A	DWS Provided?	N/A
N/A	Landing Width (in)	N/A	N/A	DWS Contrast?	N/A
N/A	Landing Slope (%)	N/A	N/A	DWS Length (in)	N/A
N/A	Landing X Slope (%)	N/A	N/A	DWS Full Width?	N/A
N/A	Landing Curb? (Y/N)	N/A	N/A	DWS Offset (in)	N/A
N/A	Shared Landing?	N/A			
N/A	Gutter Ponding?	N/A	N/A	Gutter Slope (%)	N/A
N/A	Gutter Lip Ht (in)	N/A	N/A	Gutter X Slope (%)	N/A
N/A	Painted X Walk1?	No	N/A	Painted X Walk2?	No
	X Walk 1 Direction	To NW		X Walk 2 Direction	To NE
N/A	X Walk 1 Width (in)	N/A	N/A	X Walk 2 Width (in)	N/A
	X Walk 1 Slope (%)	2.6		X Walk 2 Slope (%)	4.2
	X Walk 1 X Slope (%)	7.1		X Walk 2 X Slope (%)	6.8

**Remove & Replace Curb Ramp With Two New Directional Ramps or Equivalent.**

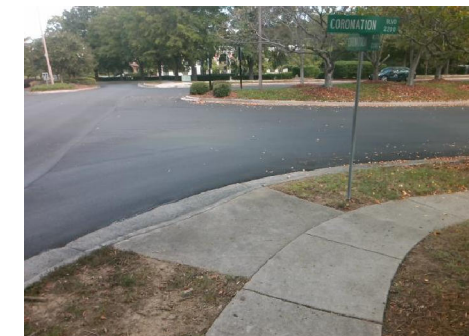
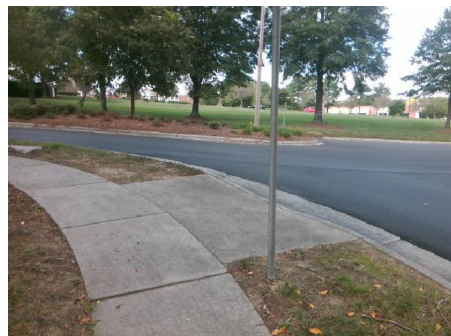
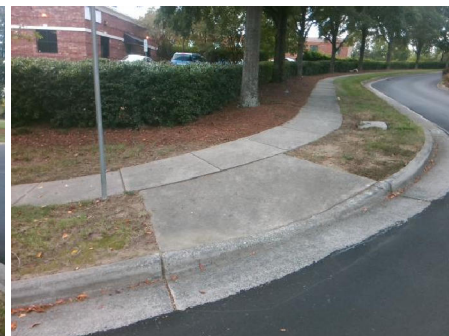
N/A	Ramp inside XWalk1?	N/A	N/A	Ramp inside XWalk2?	N/A
	Road Slope (%)	10.0	N/A	Clear Space?	N/A
	Road X Slope (%)	1.1	N/A	Clear Space to XWalk (in)	N/A
N/A	Any Obstructions?	N/A	N/A	Storm Grate/Utility Hazard?	N/A
	Obstruction Type			Storm Grate/Utility Type	
		N/A			N/A
			Yes	Surface Condition? (G/P)	Good
