# Access Compliance Report

## Public Rights-of-Way

### (Curb Ramps)

| Intersection ID: N/A | Main Street: CALABASSAS LN | Cross Street: NORTHEAT PWY | Location: SE |

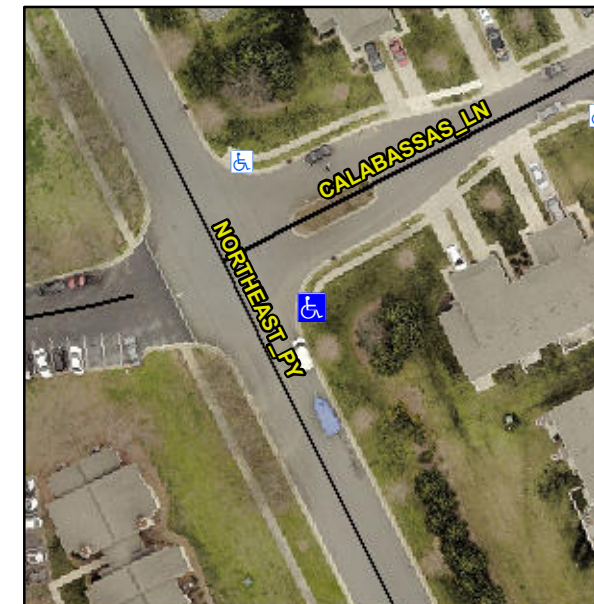
| ADA ID: 5858756AC7ED | Ramp Type: PerpDiag | Initial Pass/Fail: Fail | Overall Compliance: No |
| Severity Score: 22.5 | | | |

**R304.5.1, R304.2.2, R304.5.3**

| Compliance | Description | Data | Compliance | Description | Data |
|---|---|---|---|---|---|
| N/A | Ramp Length (in) | 48.0 | No | Ramp Slope (%) | 9.3 |
| No | Ramp Width (in) | 41.0 | No | Ramp XSlope (%) | 4.4 |

**Remove & Replace Curb Ramp With Two New Directional Ramps or Equivalent.**
