## **Access Compliance Report Public Rights-of-Way** (Curb Ramps)

Intersection ID: 47904 Main Street: CAMP VERDE LN **Cross Street: ROUND ROCK RD** Location: NE ADA ID: 585CE68ED30A Ramp Type: PerpDiag Initial Pass/Fail: Fail **Overall Compliance: No** Severity Score: 36.25

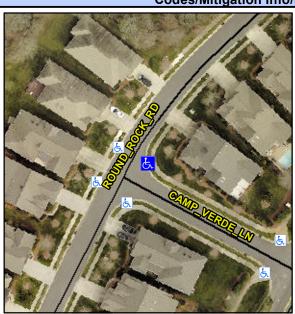
Field Measurements/Component Compliance					
Compliance Description		Data	Comp	liance Description	Data
N/A	Ramp Length (in)	49.0	Yes	Ramp Slope (%)	8.2
No	Ramp Width (in)	31.0	No	Ramp XSlope (%)	3.5
N/A	Flare Type LT	N/A	N/A	Flare Type RT	N/A
N/A	Flare Slope LT (%)	N/A	N/A	Flare Slope RT (%)	N/A
N/A	Flare Traversable LT?	N/A	N/A	Flare Traversable RT?	N/A
N/A	Landing Length (in)	N/A	N/A	DWS Provided?	N/A
N/A	Landing Width (in)	N/A	N/A	DWS Contrast?	N/A
N/A	Landing Slope (%)	N/A	N/A	DWS Length (in)	N/A
N/A	Landing X Slope (%)	N/A	N/A	DWS Full Width?	N/A
N/A	Landing Curb? (Y/N)	N/A	N/A	DWS Offset (in)	N/A
N/A	Shared Landing?	N/A			
N/A	Gutter Ponding?	N/A	N/A	Gutter Slope (%)	N/A
N/A	Gutter Lip Ht (in)	N/A	N/A	Gutter X Slope (%)	N/A
N/A	Painted X Walk1?	No	N/A	Painted X Walk2?	No
	X Walk 1 Direction	To NW		X Walk 2 Direction	To SW
N/A	X Walk 1 Width (in)	N/A	N/A	X Walk 2 Width (in)	N/A
	X Walk 1 Slope (%)	1.5		X Walk 2 Slope (%)	1.7

X Walk 1 X Slope (%)	0.3		X Walk 2 X Slope (%)	2.6
N/A	Ramp inside XWalk1?	N/A	N/A	Ramp inside XWalk2?	N/A
	Road Slope (%)	1.1	N/A	Clear Space?	N/A
	Road X Slope (%)	0.2	N/A	Clear Space to XWalk (in)	N/A
N/A	Any Obstructions?	N/A	N/A	Storm Grate/Utility Hazard?	N/A
	Obstruction Type			Storm Grate/Utility Type	
		N/A			N/A
			Yes	Surface Condition? (G/P)	Good
Med	6

Street 1 Name Stop Condition-Street 2 Street 2 Name Stop Condition-Street 1 **ROUND ROCK RD** None **CAMP VERDE LN** StopSign Possible Solutions: Remove & Replace Curb Ramp With **Two New Directional Ramps or** Equivalent. Surveyor Notes: N/A PROW/ADA: Not Found, R304.5.1, R304.5.3
