# Access Compliance Report

## Public Rights-of-Way

### (Curb Ramps)

Intersection ID: 18786	Main Street: NATIONS_FORD_RD	Cross Street: SLEEPY_HOLLOW_RD	Location: SW
ADA ID: 5863C3D9F6A2	Ramp Type: PerpDiag	Initial Pass/Fail: Fail	Overall Compliance: No
			Severity Score: 58.75

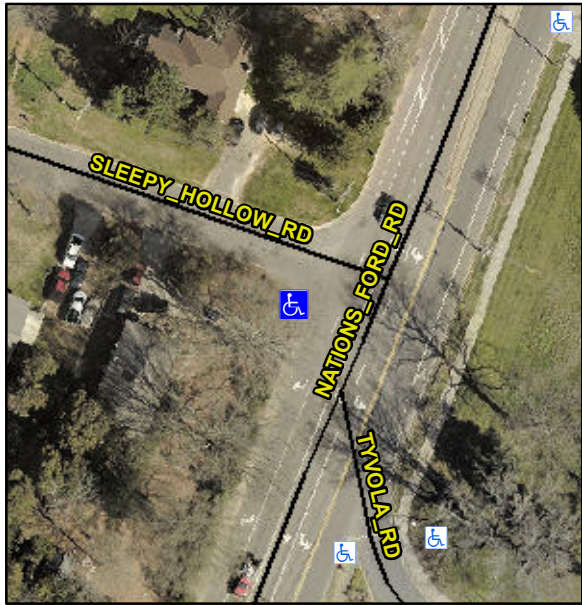
Possible Solutions:		Compliance	Description	Data	Compliance	Description	Data
	Remove & Replace Curb Ramp With Two New Directional Ramps or Equivalent.		N/A	Ramp Length (in)	45.0	No	Ramp Slope (%)	12.6
			No	Ramp Width (in)	41.0	No	Ramp XSlope (%)	9.0
			N/A	Flare Type LT	N/A	N/A	Flare Type RT	N/A
			N/A	Flare Slope LT (%)	N/A	N/A	Flare Slope RT (%)	N/A
			N/A	Flare Traversable LT?	N/A	N/A	Flare Traversable RT?	N/A
			N/A	Landing Length (in)	N/A	N/A	DWS Provided?	N/A
			N/A	Landing Width (in)	N/A	N/A	DWS Contrast?	N/A
			N/A	Landing Slope (%)	N/A	N/A	DWS Length (in)	N/A
			N/A	Landing X Slope (%)	N/A	N/A	DWS Full Width?	N/A
Surveyor Notes:	N/A		N/A	Landing Curb? (Y/N)	N/A	N/A	DWS Offset (in)	N/A
			N/A	Shared Landing?	N/A			
	PROW/ADA:		N/A	Gutter Ponding?	N/A	N/A	Gutter Slope (%)	N/A
	Not Found, R304.5.1, R304.2.2, R304.5.3		N/A	Gutter Lip Ht (in)	N/A	N/A	Gutter X Slope (%)	N/A

N/A	Painted X Walk1?	No	N/A	Painted X Walk2?	No
				X Walk 1 Direction	To E		X Walk 2 Direction	To N
			N/A	X Walk 1 Width (in)	N/A	N/A	X Walk 2 Width (in)	N/A
				X Walk 1 Slope (%)	9.3		X Walk 2 Slope (%)	1.8
				X Walk 1 X Slope (%)	1.9		X Walk 2 X Slope (%)	7.0
			N/A	Ramp inside XWalk1?	N/A	N/A	Ramp inside XWalk2?	N/A
			Road Slope (%)	7.9	N/A	Clear Space?	N/A	
			Road X Slope (%)	4.5	N/A	Clear Space to XWalk (in)	N/A	
		N/A	Any Obstructions?	N/A	N/A	Storm Grate/Utility Hazard?	N/A	
			Obstruction Type			Storm Grate/Utility Type		
					N/A		N/A	
						Yes	Surface Condition? (G/P)	Good
