# Access Compliance Report

## Public Rights-of-Way

### (Curb Ramps)

Intersection ID: 23448	Main Street: SUMMERLIN_PL	Cross Street: WEIRTON_PL	Location: NW
ADA ID: 5872C7A863A2	Ramp Type: PerpDiag	Initial Pass/Fail: Fail	Overall Compliance: No
			Severity Score: 13.75

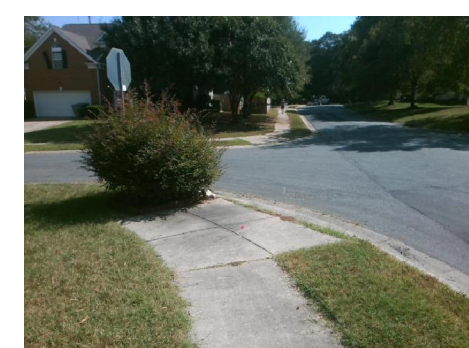
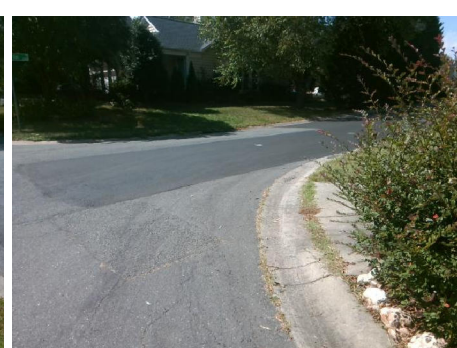
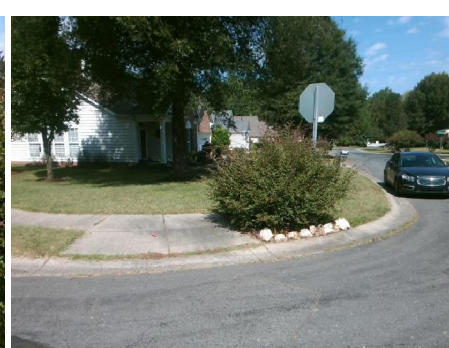
Possible Solutions:		<b>Compliance</b>	<b>Description</b>	<b>Data</b>
	<b>Remove &amp; Replace Curb Ramp With Two New Directional Ramps or Equivalent.</b>		<b>No</b>	Ramp Length (in)	<b>94.0</b>
			<b>Yes</b>	Ramp Width (in)	<b>48.0</b>
			<b>N/A</b>	Flare Type LT	<b>N/A</b>
			<b>N/A</b>	Flare Slope LT (%)	<b>N/A</b>
			<b>N/A</b>	Flare Traversable LT?	<b>N/A</b>
			<b>N/A</b>	Landing Length (in)	<b>N/A</b>
			<b>N/A</b>	Landing Width (in)	<b>N/A</b>
			<b>N/A</b>	Landing Slope (%)	<b>N/A</b>
			<b>N/A</b>	Landing X Slope (%)	<b>N/A</b>
<p>Surveyor Notes:</p> <p><b>N/A</b></p> <p>PROW/ADA:</p> <p><b>R304.2.2, R304.5.3</b></p>			<b>N/A</b>	Flare Type RT	<b>N/A</b>
			<b>N/A</b>	Flare Slope RT (%)	<b>N/A</b>
			<b>N/A</b>	Flare Traversable RT?	<b>N/A</b>
			<b>N/A</b>	DWS Provided?	<b>N/A</b>
			<b>N/A</b>	DWS Contrast?	<b>N/A</b>

<b>N/A</b>	DWS Length (in)	<b>N/A</b>
			<b>N/A</b>	DWS Full Width?	<b>N/A</b>
			<b>N/A</b>	DWS Offset (in)	<b>N/A</b>
			<b>N/A</b>	Gutter Ponding?	<b>N/A</b>
			<b>N/A</b>	Gutter Lip Ht (in)	<b>N/A</b>
<p>Total Cost:</p> <p><b>\$ 3200.00</b></p>			<b>No</b>	Painted X Walk2?	<b>No</b>
			<b>To S</b>	X Walk 2 Direction	<b>To E</b>
			<b>N/A</b>	X Walk 2 Width (in)	<b>N/A</b>
			<b>3.9</b>	X Walk 2 Slope (%)	<b>1.8</b>
			<b>0.4</b>	X Walk 2 X Slope (%)	<b>1.6</b>
			<b>N/A</b>	Ramp inside XWalk2?	<b>N/A</b>
			<b>0.3</b>	Clear Space?	<b>N/A</b>
			<b>1.2</b>	Clear Space to XWalk (in)	<b>N/A</b>
			<b>N/A</b>	Storm Grate/Utility Hazard?	<b>N/A</b>
			<b>N/A</b>	Storm Grate/Utility Type	<b>N/A</b>
			<b>N/A</b>	Surface Condition? (G/P)	<b>Good</b>
