Access Compliance Report

Public Rights-of-Way

(Curb Ramps)

Intersection ID: 28883	Main Street: BALDWIN_HALL_DR	Cross Street: CAMPBELL_HALL_CT	Location: SW
ADA ID: 5873A585510F	Ramp Type: Perp	Initial Pass/Fail: Fail	Overall Compliance: No
Codes/Mitigation Info/Possible Solution		Field Measurements/Component Compliance	
Severity Score: 8.75

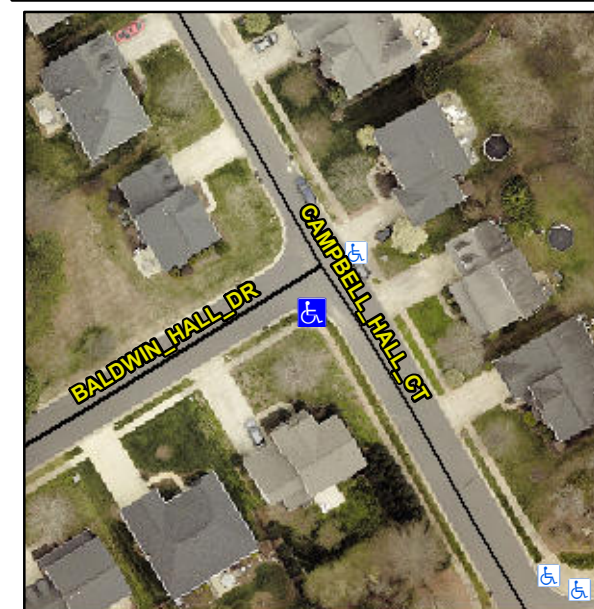
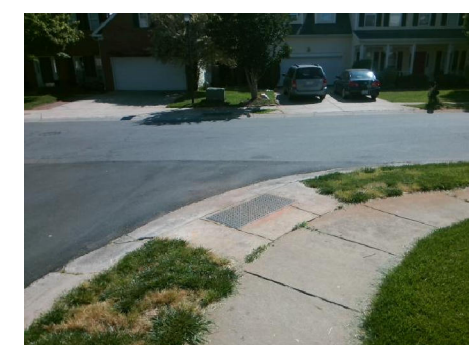
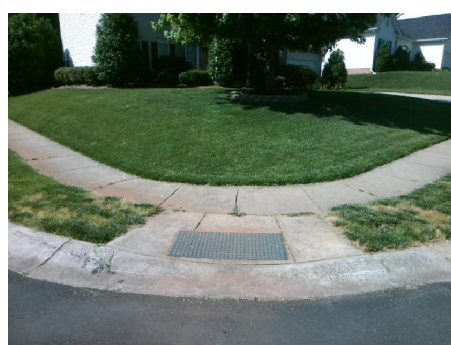
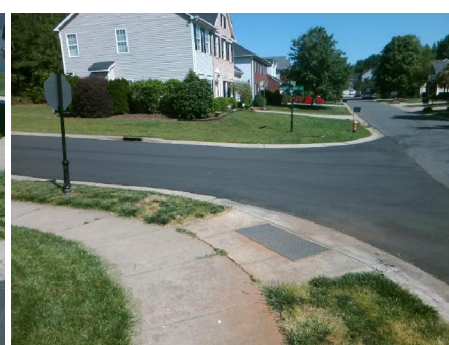
Not Found, R304.5.1

Compliance	Description	Data	Compliance	Description	Data
N/A	Ramp Length (in)	50.0	Yes	Ramp Slope (%)	5.2
No	Ramp Width (in)	37.0	Yes	Ramp XSlope (%)	0.7
N/A	Flare Type LT	N/A	N/A	Flare Type RT	N/A
N/A	Flare Slope LT (%)	N/A	N/A	Flare Slope RT (%)	N/A
N/A	Flare Traversable LT?	N/A	N/A	Flare Traversable RT?	N/A
N/A	Landing Length (in)	N/A	N/A	DWS Provided?	N/A
N/A	Landing Width (in)	N/A	N/A	DWS Contrast?	N/A
N/A	Landing Slope (%)	N/A	N/A	DWS Length (in)	N/A
N/A	Landing X Slope (%)	N/A	N/A	DWS Full Width?	N/A
N/A	Landing Curb? (Y/N)	N/A	N/A	DWS Offset (in)	N/A
N/A	Shared Landing?	N/A			
N/A	Gutter Ponding?	N/A	N/A	Gutter Slope (%)	N/A
N/A	Gutter Lip Ht (in)	N/A	N/A	Gutter X Slope (%)	N/A
N/A	Painted X Walk1?	No	N/A	Painted X Walk2?	N/A
	X Walk 1 Direction	To NE		X Walk 2 Direction	N/A
N/A	X Walk 1 Width (in)	N/A	N/A	X Walk 2 Width (in)	N/A
	X Walk 1 Slope (%)	0.2		X Walk 2 Slope (%)	N/A
	X Walk 1 X Slope (%)	0.2		X Walk 2 X Slope (%)	N/A

N/A	Ramp inside XWalk1?	N/A	N/A	Ramp inside XWalk2?	N/A
	Road Slope (%)	N/A	N/A	Clear Space?	N/A
	Road X Slope (%)	N/A	N/A	Clear Space to XWalk (in)	N/A
N/A	Any Obstructions?	N/A	N/A	Storm Grate/Utility Hazard?	N/A
	Obstruction Type			Storm Grate/Utility Type	
		N/A			N/A
			Yes	Surface Condition? (G/P)	Good

Remove & Replace Entire Ramp.
