# Access Compliance Report

## Public Rights-of-Way

### (Curb Ramps)

Intersection ID: N/A	Main Street: CITY_PARK_DR	Cross Street: TYVOLA_RD	Location: NW
ADA ID: 58757DE3EB16	Ramp Type: Perp	Initial Pass/Fail: Fail	Overall Compliance: No
			Severity Score: 21.25

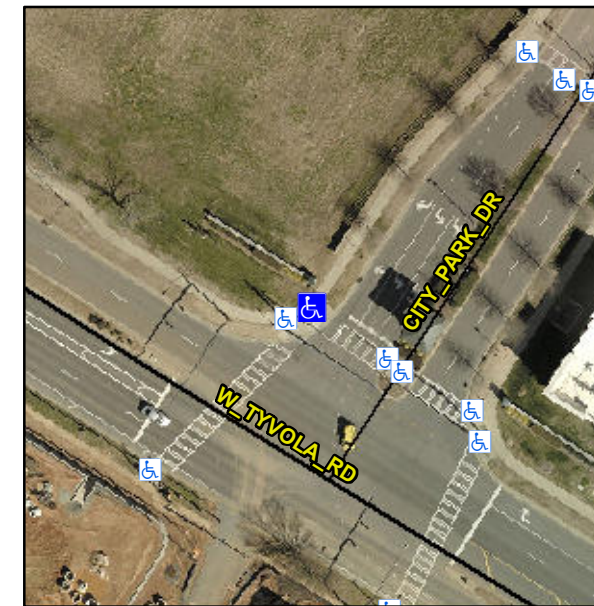
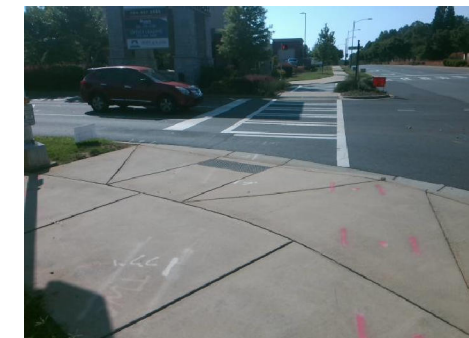
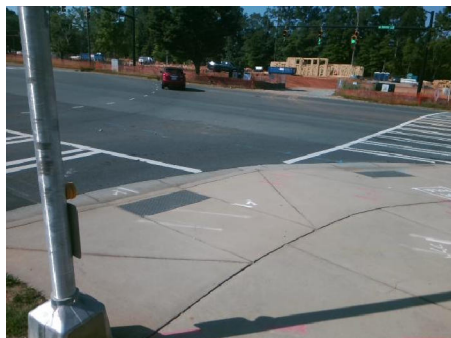
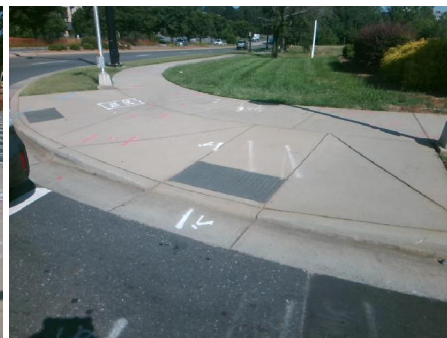
**Not Found, R304.5.1, R304.2.2**

Compliance	Description	Data	Compliance	Description	Data
N/A	Ramp Length (in)	97.0	No	Ramp Slope (%)	9.1
No	Ramp Width (in)	47.0	Yes	Ramp XSlope (%)	2.0
N/A	Flare Type LT	N/A	N/A	Flare Type RT	N/A
N/A	Flare Slope LT (%)	N/A	N/A	Flare Slope RT (%)	N/A
N/A	Flare Traversable LT?	N/A	N/A	Flare Traversable RT?	N/A
N/A	Landing Length (in)	N/A	N/A	DWS Provided?	N/A
N/A	Landing Width (in)	N/A	N/A	DWS Contrast?	N/A
N/A	Landing Slope (%)	N/A	N/A	DWS Length (in)	N/A
N/A	Landing X Slope (%)	N/A	N/A	DWS Full Width?	N/A
N/A	Landing Curb? (Y/N)	N/A	N/A	DWS Offset (in)	N/A
N/A	Shared Landing?	N/A			
N/A	Gutter Ponding?	N/A	N/A	Gutter Slope (%)	N/A
N/A	Gutter Lip Ht (in)	N/A	N/A	Gutter X Slope (%)	N/A
N/A	Painted X Walk1?	Yes	N/A	Painted X Walk2?	N/A
	X Walk 1 Direction	To SE		X Walk 2 Direction	N/A
N/A	X Walk 1 Width (in)	112.0	N/A	X Walk 2 Width (in)	N/A
	X Walk 1 Slope (%)	2.0		X Walk 2 Slope (%)	N/A
	X Walk 1 X Slope (%)	1.2		X Walk 2 X Slope (%)	N/A

N/A	Ramp inside XWalk1?	Yes	N/A	Ramp inside XWalk2?	N/A
	Road Slope (%)	N/A	N/A	Clear Space?	N/A
	Road X Slope (%)	N/A	N/A	Clear Space to XWalk (in)	N/A
N/A	Any Obstructions?	N/A	N/A	Storm Grate/Utility Hazard?	N/A
	Obstruction Type			Storm Grate/Utility Type	
		N/A			N/A
			Yes	Surface Condition? (G/P)	Good

**Remove & Replace Entire Ramp.**
