Access Compliance Report Public Rights-of-Way (Curb Ramps)

Intersection ID: 29980 Main Street: LONG_HILL_DR Cross Street: WINDING_RIVER_DR Location: NE

ADA ID: 5877D25B775A Ramp Type: BlendTrans1 Initial Pass/Fail: Fail Overall Compliance: No Severity Score: 33.75

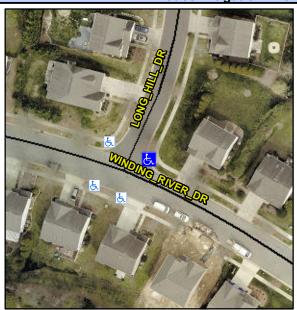
Not Found, R304.5.1, R304.5.3

Compliance Description Data Compliance Description Data Yes BlendTrans Slope (%) N/A Ramp Length (in) 77.0 4.2 No No Ramp Width (in) 47.5 BlendTrans XSlope (%) 12.5 N/A Flare Type RT N/A Flare Type LT N/A N/A N/A Flare Slope LT (%) N/A N/A Flare Slope RT (%) N/A N/A Flare Traversable LT? N/A N/A Flare Traversable RT? N/A N/A Landing Length (in) N/A N/A DWS Provided? N/A N/A Landing Width (in) N/A N/A **DWS Contrast?** N/A N/A N/A N/A Landing Slope (%) DWS Length (in) N/A N/A Landing X Slope (%) N/A N/A DWS Full Width? N/A N/A Landing Curb? (Y/N) N/A N/A DWS Offset (in) N/A N/A N/A Shared Landing? N/A **Gutter Ponding?** N/A N/A Gutter Slope (%) N/A N/A Gutter Lip Ht (in) N/A N/A Gutter X Slope (%) N/A N/A Painted X Walk1? No N/A Painted X Walk2? No X Walk 1 Direction To NW X Walk 2 Direction To SW N/A X Walk 1 Width (in) X Walk 2 Width (in) N/A X Walk 1 Slope (%) 5.2 X Walk 2 Slope (%) 0.5 X Walk 1 X Slope (%) 8.4 X Walk 2 X Slope (%) 4.9 N/A N/A Ramp inside XWalk2? N/A N/A Ramp inside XWalk1? Road Slope (%) 8.9 Clear Space? N/A Road X Slope (%) N/A Clear Space to XWalk (in) N/A 1.5 N/A N/A N/A Any Obstructions? Storm Grate/Utility Hazard? N/A **Obstruction Type** Storm Grate/Utility Type N/A N/A Yes Surface Condition? (G/P) Good No 7.6 Curb Slope (%)

Remove & Replace Curb Ramp With Two New Directional Ramps or Equivalent.
