# Access Compliance Report

## Public Rights-of-Way

### (Curb Ramps)

Intersection ID: 7349	Main Street: CRICKETEER_DR	Cross Street: N_HOSKINS_RD	Location: NE
ADA ID: 5879E0A61635	Ramp Type: Perp	Initial Pass/Fail: Fail	Overall Compliance: No
			Severity Score: 21.25

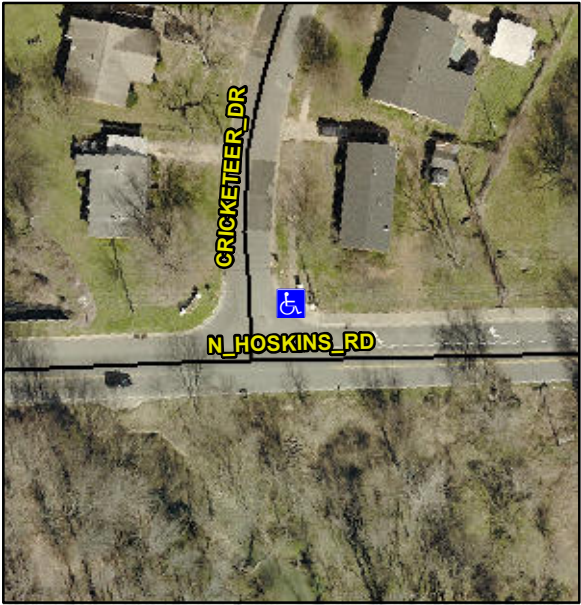
Possible Solutions:		<b>Compliance</b>	<b>Description</b>	<b>Data</b>	
	<b>Remove &amp; Replace Entire Ramp.</b>		<b>N/A</b>	Ramp Length (in)	<b>63.5</b>	<b>No</b>
			<b>No</b>	Ramp Width (in)	<b>36.0</b>	<b>Yes</b>
			<b>N/A</b>	Flare Type LT	<b>N/A</b>	<b>N/A</b>
			<b>N/A</b>	Flare Slope LT (%)	<b>N/A</b>	<b>N/A</b>
			<b>N/A</b>	Flare Traversable LT?	<b>N/A</b>	<b>N/A</b>
			<b>N/A</b>	Landing Length (in)	<b>N/A</b>	<b>N/A</b>
			<b>N/A</b>	Landing Width (in)	<b>N/A</b>	<b>N/A</b>
			<b>N/A</b>	Landing Slope (%)	<b>N/A</b>	<b>N/A</b>
			<b>N/A</b>	Landing X Slope (%)	<b>N/A</b>	<b>N/A</b>
			<b>N/A</b>	Landing Curb? (Y/N)	<b>N/A</b>	<b>N/A</b>
			<b>N/A</b>	Shared Landing?	<b>N/A</b>	
			<b>N/A</b>	Gutter Ponding?	<b>N/A</b>	<b>N/A</b>
			<b>N/A</b>	Gutter Lip Ht (in)	<b>N/A</b>	<b>N/A</b>
			<b>N/A</b>	Painted X Walk1?	<b>No</b>	<b>N/A</b>

X Walk 1 Direction	<b>To W</b>	<b>N/A</b>
			<b>N/A</b>	X Walk 1 Width (in)	<b>N/A</b>	<b>N/A</b>
				X Walk 1 Slope (%)	<b>4.4</b>	<b>N/A</b>
				X Walk 1 X Slope (%)	<b>2.0</b>	<b>N/A</b>
			<b>N/A</b>	Ramp inside XWalk1?	<b>N/A</b>	<b>N/A</b>
<p>Surveyor Notes:</p> <p><b>N/A</b></p> <p>PROW/ADA:</p> <p><b>Not Found, R304.5.1, R304.2.2</b></p>			<b>N/A</b>	Road Slope (%)	<b>2.0</b>	<b>N/A</b>
				Road X Slope (%)	<b>4.4</b>	<b>N/A</b>
			<b>N/A</b>	Any Obstructions?	<b>N/A</b>	<b>N/A</b>
				Obstruction Type		
					<b>N/A</b>	<b>N/A</b>
			<b>Yes</b>	Surface Condition? (G/P)		<b>Good</b>
Total Cost:		\$ 1850.00
