# Access Compliance Report

## Public Rights-of-Way

### (Curb Ramps)

Intersection ID: 18127	Main Street: BRANDYWINE_RD	Cross Street: SELWYN_AV	Location: NW
ADA ID: 5883C878662A	Ramp Type: PerpDiag	Initial Pass/Fail: Fail	Overall Compliance: No
			Severity Score: 26.25

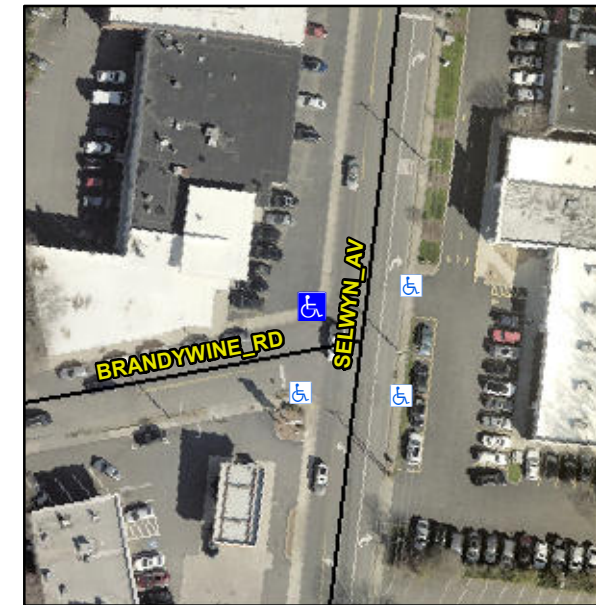
Compliance	Description	Data	Compliance	Description	Data
N/A	Ramp Length (in)	48.0	No	Ramp Slope (%)	18.5
Yes	Ramp Width (in)	48.0	No	Ramp XSlope (%)	2.5
N/A	Flare Type LT	N/A	N/A	Flare Type RT	N/A
N/A	Flare Slope LT (%)	N/A	N/A	Flare Slope RT (%)	N/A
N/A	Flare Traversable LT?	N/A	N/A	Flare Traversable RT?	N/A
N/A	Landing Length (in)	N/A	N/A	DWS Provided?	N/A
N/A	Landing Width (in)	N/A	N/A	DWS Contrast?	N/A
N/A	Landing Slope (%)	N/A	N/A	DWS Length (in)	N/A
N/A	Landing X Slope (%)	N/A	N/A	DWS Full Width?	N/A
N/A	Landing Curb? (Y/N)	N/A	N/A	DWS Offset (in)	N/A
N/A	Shared Landing?	N/A			
N/A	Gutter Ponding?	N/A	N/A	Gutter Slope (%)	N/A
N/A	Gutter Lip Ht (in)	N/A	N/A	Gutter X Slope (%)	N/A
N/A	Painted X Walk1?	No	N/A	Painted X Walk2?	No
	X Walk 1 Direction	To SW		X Walk 2 Direction	To E
N/A	X Walk 1 Width (in)	N/A	N/A	X Walk 2 Width (in)	N/A
	X Walk 1 Slope (%)	2.6		X Walk 2 Slope (%)	5.6
	X Walk 1 X Slope (%)	4.5		X Walk 2 X Slope (%)	3.2

N/A	Ramp inside XWalk1?	N/A	N/A	Ramp inside XWalk2?	N/A
	Road Slope (%)	1.7	N/A	Clear Space?	N/A
	Road X Slope (%)	6.9	N/A	Clear Space to XWalk (in)	N/A
N/A	Any Obstructions?	N/A	N/A	Storm Grate/Utility Hazard?	N/A
	Obstruction Type			Storm Grate/Utility Type	
		N/A			N/A
			Yes	Surface Condition? (G/P)	Good

Possible Solutions:

**Remove & Replace Curb Ramp With Two New Directional Ramps or Equivalent.**

PROW/ADA:

**R304.2.2, R304.5.3**
