# Access Compliance Report

## Public Rights-of-Way

| Intersection ID: 46809 | Main Street: AZALEA_HILLS_DR | Cross Street: CLAUDE_FREEMAN_DR | Location: SW |
| ADA ID: 588514C964BA | Ramp Type: BlendTrans1 | Initial Pass/Fail: Fail | Overall Compliance: No |

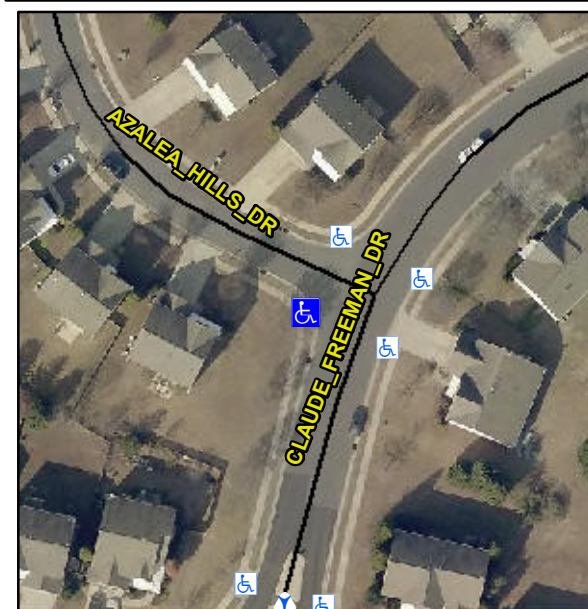
| | | Severity Score: 21.25 | |

**Not Found, R304.5.1, R304.5.3**

| Compliance | Description | Data | Compliance | Description | Data |
|---|---|---|---|---|---|
| N/A | Ramp Length (in) | 46.5 | Yes | BlendTrans Slope (%) | 4.2 |
| No | Ramp Width (in) | 46.5 | No | BlendTrans XSlope (%) | 5.3 |
| | | | No | Curb Slope (%) | 5.3 |

**Remove & Replace Curb Ramp With Two New Directional Ramps or Equivalent.**

Total Cost: \$ 3200.00
