Access Compliance Report

Public Rights-of-Way

(Curb Ramps)

Intersection ID: 11775	Main Street: E_18TH_ST	Cross Street: SEIGLE_AV	Location: NW
ADA ID: 588BCFDF1CE3	Ramp Type: Perp	Initial Pass/Fail: Fail	Overall Compliance: No
Severity Score: 25			
Codes/Mitigation Info/Possible Solution		Field Measurements/Component Compliance

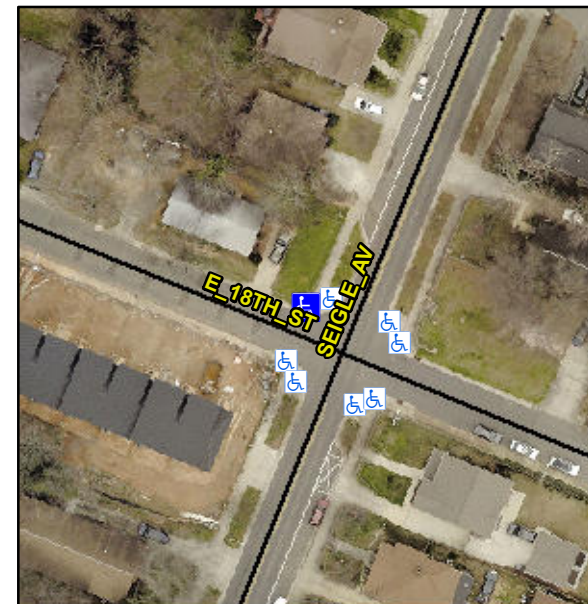
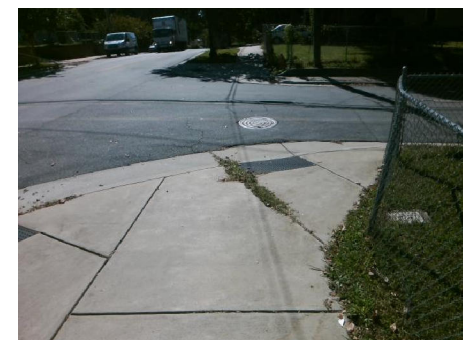
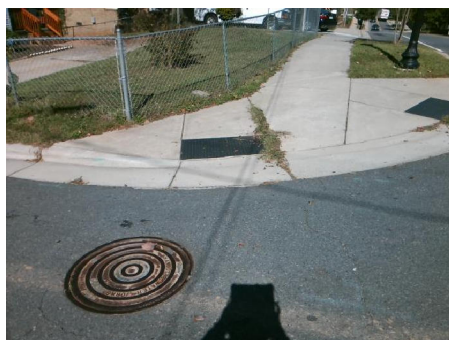
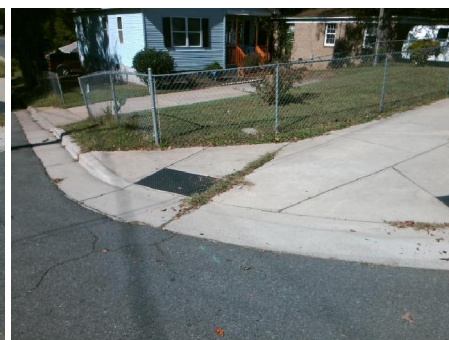
R304.5.3

Compliance	Description	Data	Compliance	Description	Data
N/A	Ramp Length (in)	75.0	Yes	Ramp Slope (%)	6.5
Yes	Ramp Width (in)	48.0	No	Ramp XSlope (%)	7.4
N/A	Flare Type LT	N/A	N/A	Flare Type RT	N/A
N/A	Flare Slope LT (%)	N/A	N/A	Flare Slope RT (%)	N/A
N/A	Flare Traversable LT?	N/A	N/A	Flare Traversable RT?	N/A
N/A	Landing Length (in)	N/A	N/A	DWS Provided?	N/A
N/A	Landing Width (in)	N/A	N/A	DWS Contrast?	N/A
N/A	Landing Slope (%)	N/A	N/A	DWS Length (in)	N/A
N/A	Landing X Slope (%)	N/A	N/A	DWS Full Width?	N/A
N/A	Landing Curb? (Y/N)	N/A	N/A	DWS Offset (in)	N/A
N/A	Shared Landing?	N/A			
N/A	Gutter Ponding?	N/A	N/A	Gutter Slope (%)	N/A
N/A	Gutter Lip Ht (in)	1.5	N/A	Gutter X Slope (%)	N/A
N/A	Painted X Walk1?	No	N/A	Painted X Walk2?	N/A
	X Walk 1 Direction	To SW		X Walk 2 Direction	N/A
N/A	X Walk 1 Width (in)	N/A	N/A	X Walk 2 Width (in)	N/A
	X Walk 1 Slope (%)	6.4		X Walk 2 Slope (%)	N/A
	X Walk 1 X Slope (%)	10.3		X Walk 2 X Slope (%)	N/A

N/A	Ramp inside XWalk1?	N/A	N/A	Ramp inside XWalk2?	N/A
	Road Slope (%)	N/A	N/A	Clear Space?	N/A
	Road X Slope (%)	N/A	N/A	Clear Space to XWalk (in)	N/A
N/A	Any Obstructions?	N/A	N/A	Storm Grate/Utility Hazard?	N/A
	Obstruction Type			Storm Grate/Utility Type	
		N/A			N/A
			Yes	Surface Condition? (G/P)	Good

Possible Solutions:

Remove & Replace Entire Ramp.

Total Cost: \$ **1850.00**
