# Access Compliance Report

## Public Rights-of-Way

| Intersection ID: 44062 | Main Street: WESTMILL_LN | Cross Street: SEDGEMOOR_LN | Location: E |
| ADA ID: 58913079AB05 | Ramp Type: PerpDiag | Initial Pass/Fail: Pass | Overall Compliance: No |

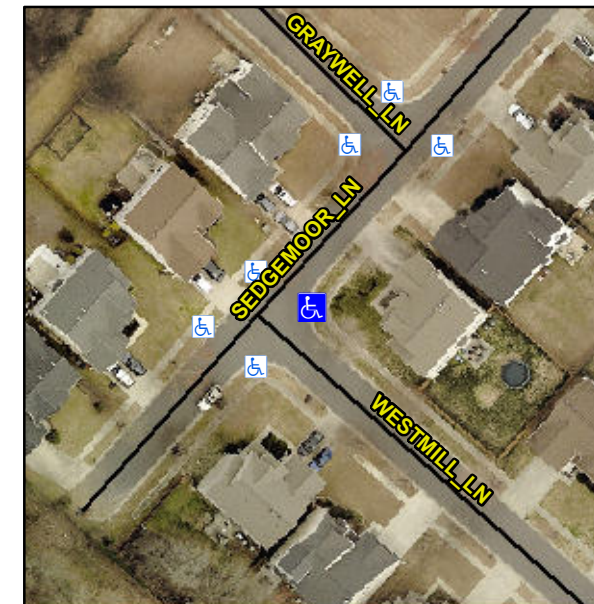
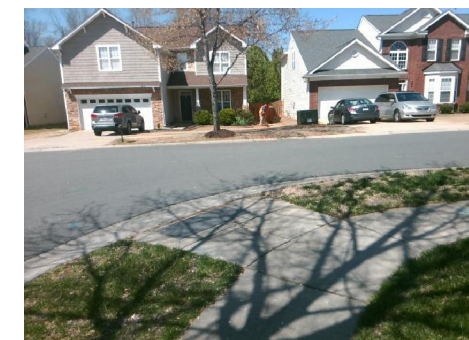
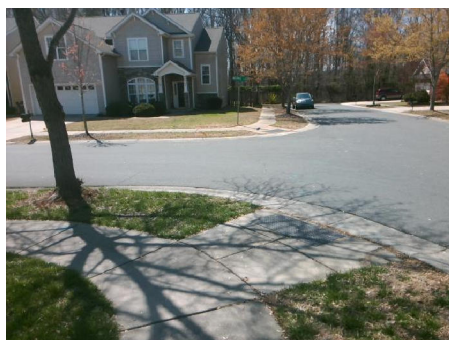
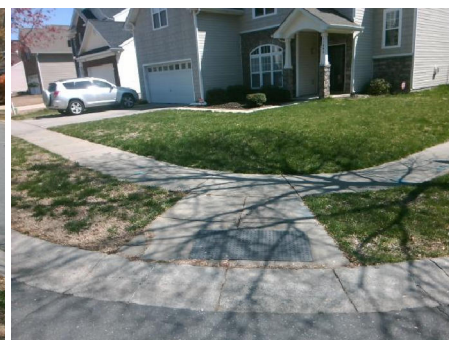
| Severity Score: 4.25 | | | |

**R304.5.3, R304.2.1, R304.2.2-Perp, R304.3.2-Para, R305.2**

| Compliance | Description | Data | Compliance | Description | Data |
|---|---|---|---|---|---|
| Yes | Ramp Width (in) | 66.0 | No | Ramp XSlope (%) | 3.6 |
| No | Landing Length (in) | 47.0 | Yes | DWS Provided? | Yes |
| No | Landing Width (in) | 45.0 | Yes | DWS Contrast? | Yes |
| No | Landing Slope (%) | 2.4 | Yes | DWS Length (in) | 24.0 |
| No | Landing X Slope (%) | 5.5 | Yes | DWS Full Width? | Yes |
| N/A | Landing Curb? (Y/N) | No | No | DWS Offset (in) | 3.0 |
| Yes | Gutter Lip Ht (in) | 0.0 | No | Gutter X Slope (%) | 5.6 |

**Remove & Replace Curb Ramp With Two New Directional Ramps or Equivalent. Remove & Replace Gutter.**
