Access Compliance Report

Public Rights-of-Way

(Curb Ramps)

Intersection ID: 47670	Main Street: COLLINGHAM_DR	Cross Street: FENWAY_DR	Location: SE
ADA ID: 5895935BC47E	Ramp Type: Perp	Initial Pass/Fail: Fail	Overall Compliance: No
Severity Score: 8.75			
Codes/Mitigation Info/Possible Solution		Field Measurements/Component Compliance

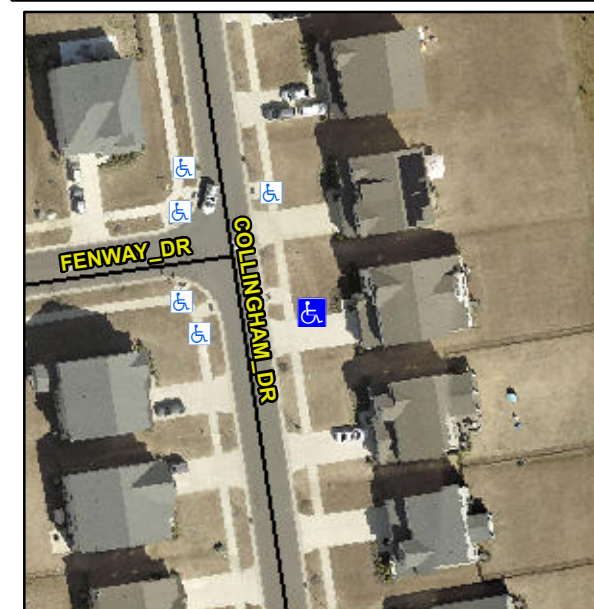
Compliance	Description	Data	Compliance	Description	Data
N/A	Ramp Length (in)	95.0	Yes	Ramp Slope (%)	5.5
No	Ramp Width (in)	47.0	Yes	Ramp XSlope (%)	1.2
N/A	Flare Type LT	N/A	N/A	Flare Type RT	N/A
N/A	Flare Slope LT (%)	N/A	N/A	Flare Slope RT (%)	N/A
N/A	Flare Traversable LT?	N/A	N/A	Flare Traversable RT?	N/A
N/A	Landing Length (in)	N/A	N/A	DWS Provided?	N/A
N/A	Landing Width (in)	N/A	N/A	DWS Contrast?	N/A
N/A	Landing Slope (%)	N/A	N/A	DWS Length (in)	N/A
N/A	Landing X Slope (%)	N/A	N/A	DWS Full Width?	N/A
N/A	Landing Curb? (Y/N)	N/A	N/A	DWS Offset (in)	N/A
N/A	Shared Landing?	N/A			
N/A	Gutter Ponding?	N/A	N/A	Gutter Slope (%)	N/A
N/A	Gutter Lip Ht (in)	N/A	N/A	Gutter X Slope (%)	N/A
N/A	Painted X Walk1?	No	N/A	Painted X Walk2?	N/A
	X Walk 1 Direction	To W		X Walk 2 Direction	N/A
N/A	X Walk 1 Width (in)	N/A	N/A	X Walk 2 Width (in)	N/A
	X Walk 1 Slope (%)	3.1		X Walk 2 Slope (%)	N/A
	X Walk 1 X Slope (%)	0.0		X Walk 2 X Slope (%)	N/A

N/A	Ramp inside XWalk1?	N/A	N/A	Ramp inside XWalk2?	N/A
	Road Slope (%)	N/A	N/A	Clear Space?	N/A
	Road X Slope (%)	N/A	N/A	Clear Space to XWalk (in)	N/A
N/A	Any Obstructions?	N/A	N/A	Storm Grate/Utility Hazard?	N/A
	Obstruction Type			Storm Grate/Utility Type	
		N/A			N/A
		Yes		Surface Condition? (G/P)	Good

Remove & Replace Entire Ramp.

R304.5.1

\$ 1850.00
