Intersection ID: 10053	Main Street: BURTON_ST	Cross Street: FONTANA_AV	Location:	NE
ADA ID: 58A212D163B7	Ramp Type: Perp	Initial Pass/Fail: Fail	Overall Compliance: No	Severity Score: 13.75

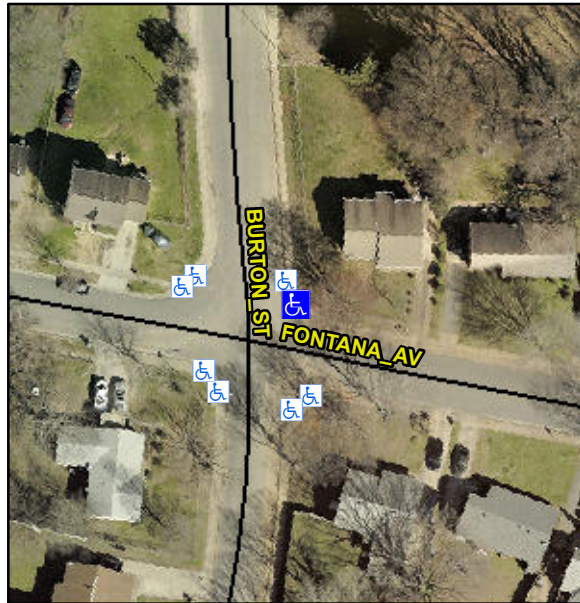
**Not Found, R304.2.2, R304.5.3**

Compliance	Description	Data	Compliance	Description	Data
N/A	Ramp Length (in)	62.0	No	Ramp Slope (%)	10.0
Yes	Ramp Width (in)	48.0	No	Ramp XSlope (%)	3.0
N/A	Flare Type LT	N/A	N/A	Flare Type RT	N/A
N/A	Flare Slope LT (%)	N/A	N/A	Flare Slope RT (%)	N/A
N/A	Flare Traversable LT?	N/A	N/A	Flare Traversable RT?	N/A
N/A	Landing Length (in)	N/A	N/A	DWS Provided?	N/A
N/A	Landing Width (in)	N/A	N/A	DWS Contrast?	N/A
N/A	Landing Slope (%)	N/A	N/A	DWS Length (in)	N/A
N/A	Landing X Slope (%)	N/A	N/A	DWS Full Width?	N/A
N/A	Landing Curb? (Y/N)	N/A	N/A	DWS Offset (in)	N/A
N/A	Shared Landing?	N/A			
N/A	Gutter Ponding?	N/A	N/A	Gutter Slope (%)	N/A
N/A	Gutter Lip Ht (in)	1.0	N/A	Gutter X Slope (%)	N/A
N/A	Painted X Walk1?	No	N/A	Painted X Walk2?	N/A
	X Walk 1 Direction	To S		X Walk 2 Direction	N/A
N/A	X Walk 1 Width (in)	N/A	N/A	X Walk 2 Width (in)	N/A
	X Walk 1 Slope (%)	1.4		X Walk 2 Slope (%)	N/A
	X Walk 1 X Slope (%)	0.0		X Walk 2 X Slope (%)	N/A

N/A	Ramp inside XWalk1?	N/A	N/A	Ramp inside XWalk2?	N/A
	Road Slope (%)	N/A	N/A	Clear Space?	N/A
	Road X Slope (%)	N/A	N/A	Clear Space to XWalk (in)	N/A
N/A	Any Obstructions?	N/A	N/A	Storm Grate/Utility Hazard?	N/A
	Obstruction Type			Storm Grate/Utility Type	
		N/A			N/A
			Yes	Surface Condition? (G/P)	Good

### Possible Solutions:

### Remove & Replace Entire Ramp.
