# Access Compliance Report

## Public Rights-of-Way

### (Curb Ramps)

| Intersection ID: 19725 | Main Street: COLONY_RD | Cross Street: GOVERNOR_MORRISON_ST | Location: E |

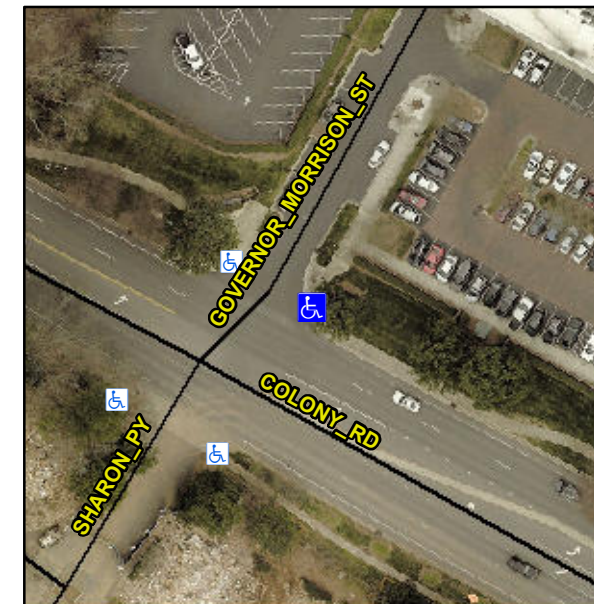
| ADA ID: 58A27D5BE52E | Ramp Type: PerpDiag | Initial Pass/Fail: Fail | Overall Compliance: No |

**Not Found, R304.2.2**

| Compliance | Description | Data | Compliance | Description | Data |
|---|---|---|---|---|---|
| N/A | Ramp Length (in) | 71.0 | No | Ramp Slope (%) | 8.6 |

**Remove & Replace Curb Ramp With Two New Directional Ramps or Equivalent.**

Total Cost: \$ 3200.00
