# Access Compliance Report

## Public Rights-of-Way

### (Curb Ramps)

Intersection ID: 53763	Main Street: NORTH_COMMUNITY_HOUSE_RD	Cross Street: COMMUNITY_COMMONS_RD	Location: NE
ADA ID: 58A63D3FB54F	Ramp Type: Directional	Initial Pass/Fail: Pass	Overall Compliance: Yes
Severity Score: 0			
Codes/Mitigation Info/Possible Solution		Field Measurements/Component Compliance

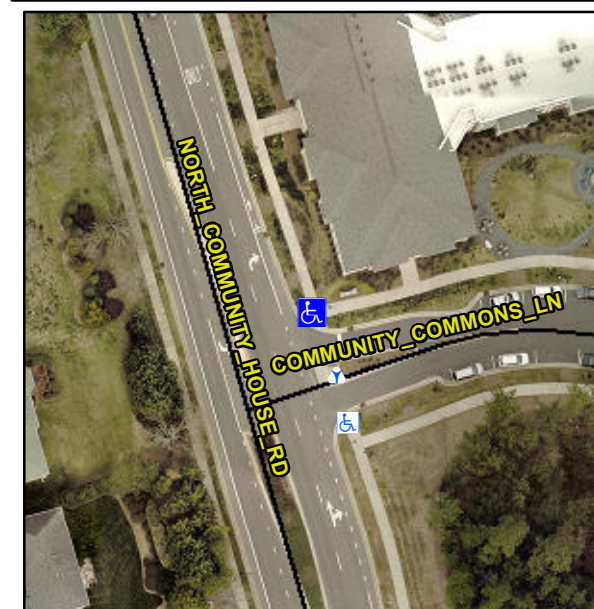
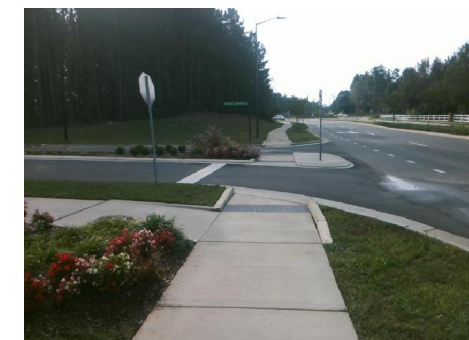
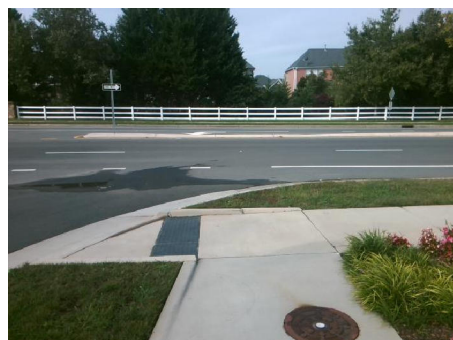
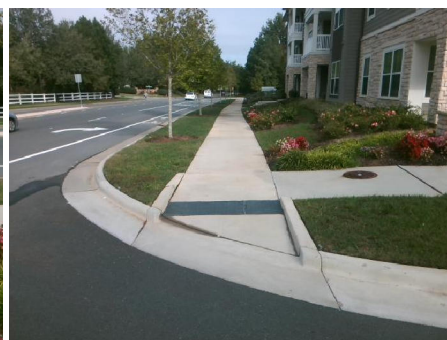
Compliance	Description	Data	Compliance	Description	Data
N/A	Ramp Length (in)	96.0	Yes	Grade Break?	Yes
Yes	Ramp Width (in)	70.0	Yes	Grade Break Slope (%)	1.9
Yes	Ramp Slope (%)	2.9	Yes	Grade Break XSlope (%)	1.9
Yes	Ramp XSlope (%)	1.4			
Yes	Flare Type LT	N/A	Yes	Flare Type RT	N/A
N/A	Flare Slope LT (%)	N/A	N/A	Flare Slope RT (%)	N/A
N/A	Flare Traversable LT?	No	N/A	Flare Traversable RT?	No
Yes	Landing Length (in)	71.0	Yes	DWS Provided?	Yes
Yes	Landing Width (in)	71.0	Yes	DWS Contrast?	Yes
Yes	Landing Slope (%)	1.2	Yes	DWS Length (in)	24.0
Yes	Landing X Slope (%)	1.7	Yes	DWS Full Width?	Yes
N/A	Landing Curb? (Y/N)	No	Yes	DWS Offset LT (in)	0.0
N/A	Shared Landing?	No	Yes	DWS Offset RT (in)	48.0
Yes	Gutter Ponding?	No	Yes	Gutter Slope (%)	2.1
Yes	Gutter Lip Ht (in)	0.0	Yes	Gutter X Slope (%)	1.3
N/A	Painted X Walk1?	No		Road Slope (%)	2.3
	X Walk 1 Direction	To SE		Road X Slope (%)	0.7
	X Walk 1 Width (in)	N/A		Clear Space?	Yes

X Walk 1 Slope (%)	2.3	N/A	Clear Space to XWalk (in)	N/A
	X Walk 1 X Slope (%)	0.7	Yes	Storm Grate/Utility Hazard?	No
N/A	Ramp inside XWalk1?	N/A		Storm Grate/Utility Type	
Yes	Any Obstructions?	No			N/A
	Obstruction Type		Yes	Surface Condition? (G/P)	Good
			N/A	Curb Slope (%)	6.1
