# Access Compliance Report

## Public Rights-of-Way

### (Curb Ramps)

Intersection ID: 4829	Main Street: ARKLOW_RD	Cross Street: SADDLE_TRAIL_LN	Location: S
ADA ID: 58AA6F15EB56	Ramp Type: Perp	Initial Pass/Fail: Fail	Overall Compliance: No
Codes/Mitigation Info/Possible Solution		Field Measurements/Component Compliance

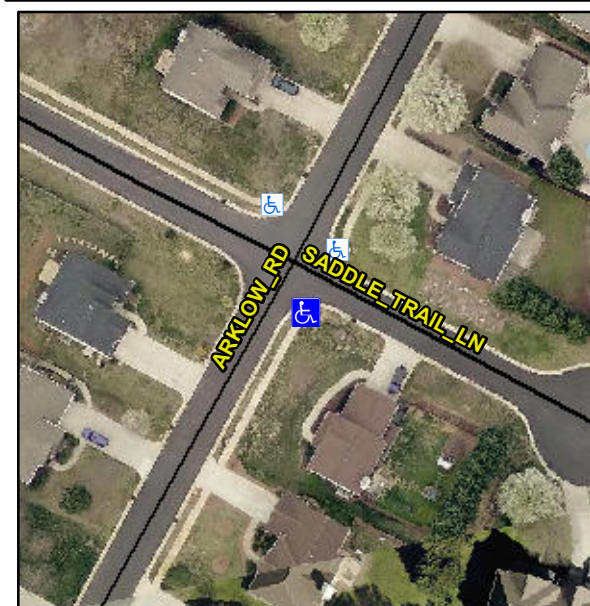
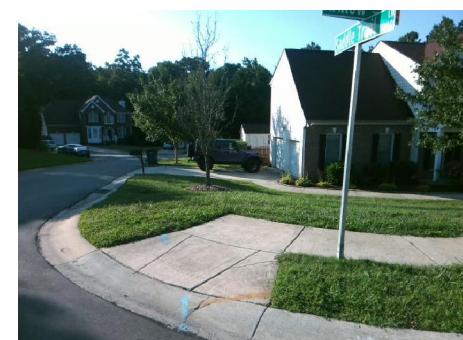
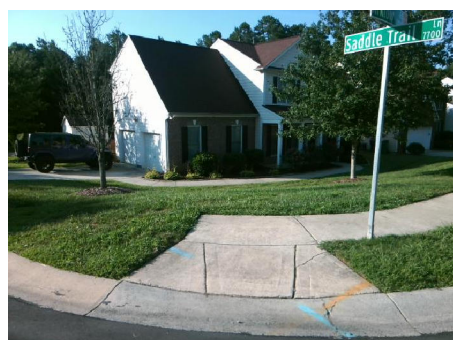
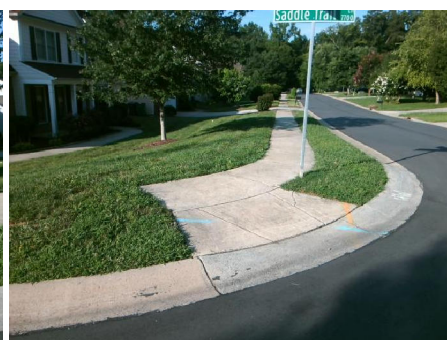
Compliance	Description	Data	Compliance	Description	Data
N/A	Ramp Length (in)	47.0	Yes	Ramp Slope (%)	6.8
No	Ramp Width (in)	34.0	No	Ramp XSlope (%)	2.1
N/A	Flare Type LT	N/A	N/A	Flare Type RT	N/A
N/A	Flare Slope LT (%)	N/A	N/A	Flare Slope RT (%)	N/A
N/A	Flare Traversable LT?	N/A	N/A	Flare Traversable RT?	N/A
N/A	Landing Length (in)	N/A	N/A	DWS Provided?	N/A
N/A	Landing Width (in)	N/A	N/A	DWS Contrast?	N/A
N/A	Landing Slope (%)	N/A	N/A	DWS Length (in)	N/A
N/A	Landing X Slope (%)	N/A	N/A	DWS Full Width?	N/A
N/A	Landing Curb? (Y/N)	N/A	N/A	DWS Offset (in)	N/A
N/A	Shared Landing?	N/A			
N/A	Gutter Ponding?	N/A	N/A	Gutter Slope (%)	N/A
N/A	Gutter Lip Ht (in)	N/A	N/A	Gutter X Slope (%)	N/A
N/A	Painted X Walk1?	No	N/A	Painted X Walk2?	N/A
	X Walk 1 Direction	To NE		X Walk 2 Direction	N/A
N/A	X Walk 1 Width (in)	N/A	N/A	X Walk 2 Width (in)	N/A
	X Walk 1 Slope (%)	6.0		X Walk 2 Slope (%)	N/A
	X Walk 1 X Slope (%)	5.8		X Walk 2 X Slope (%)	N/A

N/A	Ramp inside XWalk1?	N/A	N/A	Ramp inside XWalk2?	N/A
	Road Slope (%)	N/A	N/A	Clear Space?	N/A
	Road X Slope (%)	N/A	N/A	Clear Space to XWalk (in)	N/A
N/A	Any Obstructions?	N/A	N/A	Storm Grate/Utility Hazard?	N/A
	Obstruction Type			Storm Grate/Utility Type	
			N/A		N/A
			Yes	Surface Condition? (G/P)	Good

**Remove & Replace Entire Ramp.**

**R304.5.1, R304.5.3**
