Access Compliance Report

Public Rights-of-Way

(Curb Ramps)

Intersection ID: 29142	Main Street: APPLEDALE_DR	Cross Street: BRIDGEVILLE_LN	Location: W
ADA ID: 58ACDA2B4836	Ramp Type: PerpDiag	Initial Pass/Fail: Fail	Overall Compliance: No
Severity Score: 22.5			
Codes/Mitigation Info/Possible Solution		Field Measurements/Component Compliance

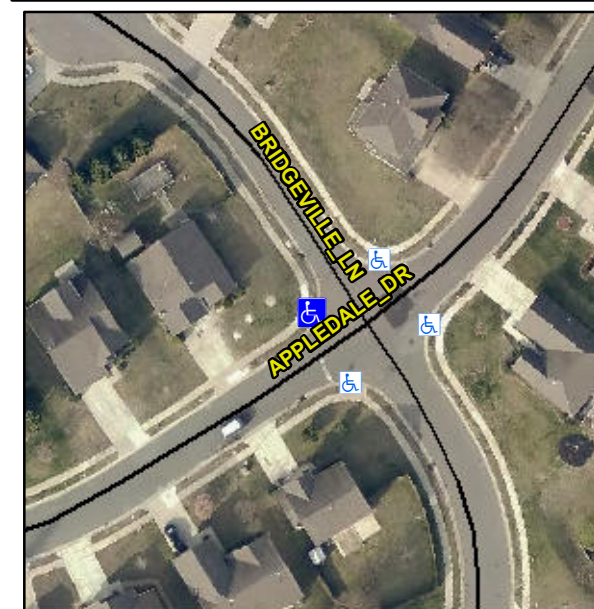
Not Found, R304.5.1, R304.2.2, R304.5.3

Compliance	Description	Data	Compliance	Description	Data
N/A	Ramp Length (in)	47.5	No	Ramp Slope (%)	9.4
No	Ramp Width (in)	47.0	No	Ramp XSlope (%)	3.0
N/A	Flare Type LT	N/A	N/A	Flare Type RT	N/A
N/A	Flare Slope LT (%)	N/A	N/A	Flare Slope RT (%)	N/A
N/A	Flare Traversable LT?	N/A	N/A	Flare Traversable RT?	N/A
N/A	Landing Length (in)	N/A	N/A	DWS Provided?	N/A
N/A	Landing Width (in)	N/A	N/A	DWS Contrast?	N/A
N/A	Landing Slope (%)	N/A	N/A	DWS Length (in)	N/A
N/A	Landing X Slope (%)	N/A	N/A	DWS Full Width?	N/A
N/A	Landing Curb? (Y/N)	N/A	N/A	DWS Offset (in)	N/A
N/A	Shared Landing?	N/A			
N/A	Gutter Ponding?	N/A	N/A	Gutter Slope (%)	N/A
N/A	Gutter Lip Ht (in)	N/A	N/A	Gutter X Slope (%)	N/A
N/A	Painted X Walk1?	No	N/A	Painted X Walk2?	No
	X Walk 1 Direction	To S		X Walk 2 Direction	To E
N/A	X Walk 1 Width (in)	N/A	N/A	X Walk 2 Width (in)	N/A
	X Walk 1 Slope (%)	4.0		X Walk 2 Slope (%)	2.7
	X Walk 1 X Slope (%)	4.1		X Walk 2 X Slope (%)	2.5

N/A	Ramp inside XWalk1?	N/A	N/A	Ramp inside XWalk2?	N/A
	Road Slope (%)	2.7	N/A	Clear Space?	N/A
	Road X Slope (%)	5.4	N/A	Clear Space to XWalk (in)	N/A
N/A	Any Obstructions?	N/A	N/A	Storm Grate/Utility Hazard?	N/A
	Obstruction Type			Storm Grate/Utility Type	
		N/A			N/A
			Yes	Surface Condition? (G/P)	Good

Possible Solutions:

Remove & Replace Curb Ramp With Two New Directional Ramps or Equivalent.
