# Access Compliance Report

## Public Rights-of-Way

### (Curb Ramps)

| Intersection ID: 24562 | Main Street: CAVAN_CT | Cross Street: SWINFORD_PL | Location: SE |

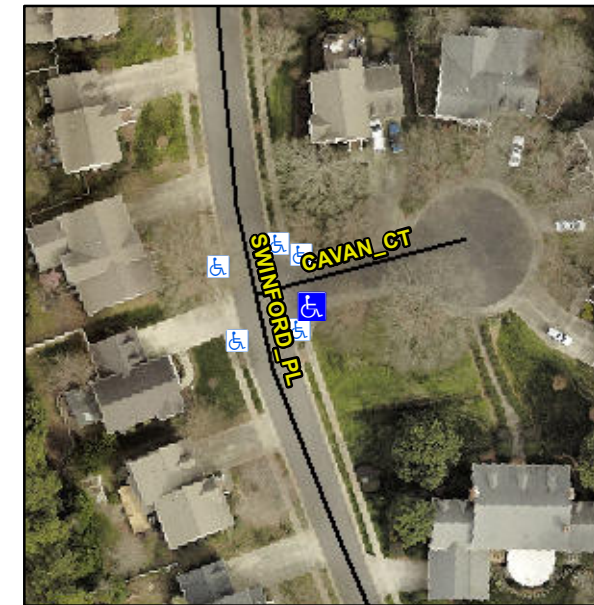
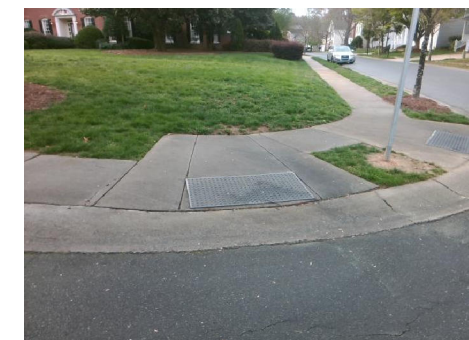
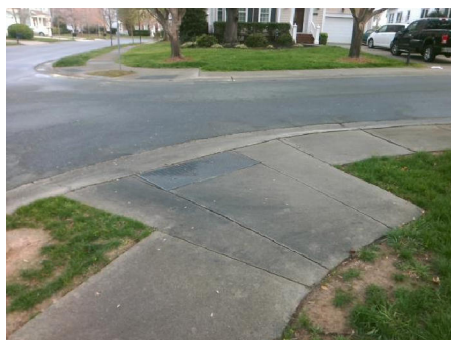
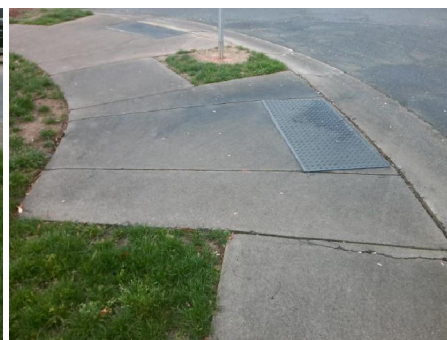
| ADA ID: 58D314597BB1 | Ramp Type: Perp | Initial Pass/Fail: Fail | Overall Compliance: No |
| | | Severity Score: 10 | |

**Not Found, R304.5.1, R304.5.3**

| Compliance | Description | Data | Compliance | Description | Data |
|---|---|---|---|---|---|
| N/A | Ramp Length (in) | 48.0 | Yes | Ramp Slope (%) | 7.2 |
| No | Ramp Width (in) | 42.0 | No | Ramp XSlope (%) | 3.0 |

**Remove & Replace Entire Ramp.**

Total Cost: \$ 1850.00
